The Evaluation of Wetland and Riparian Restoration Projects

Jeffrey C. Davis and Gay A. Muhlberg

Alaska Department of Fish and Game, Habitat and Restoration Division, Anchorage, AK.

April, 2002

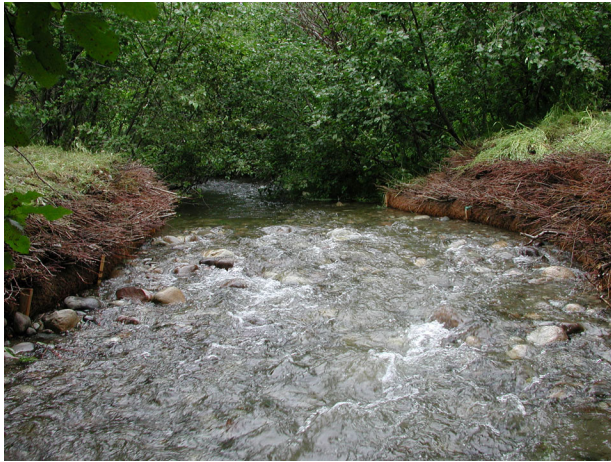
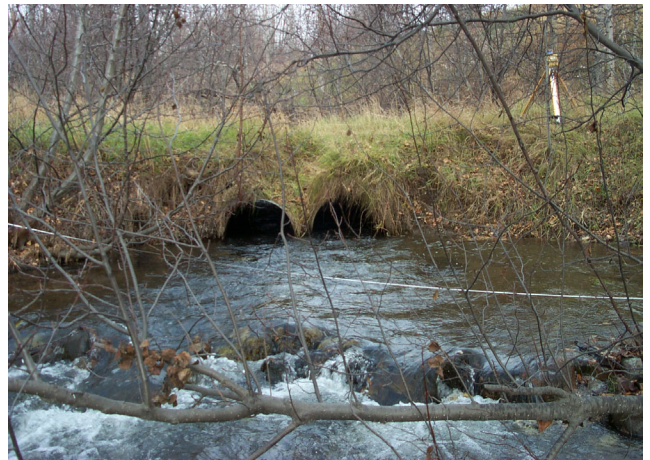
Following culvert removal water velocities decreased substantially at both the upstream and downstream transect locations (TableA-2). Mean water velocities within the restored reach were still fairly high; however, there were areas of considerably lower velocities, particularly along the right bank where velocities of 0.03-m/s were measured. Juvenile fish were not sampled following the culvert removal; however, spawning adult coho salmon were observed throughout the restored section of stream. Both the upstream and downstream scour pools began to fill with substrate following culvert removal (Figure A-3). This reduction in stream depth without a corresponding reduction in stream width resulted in an increase in ratios of width to depth.

Figure A-3. Photographs taken from photo point located downstream of restored reach one week following design implementation (left) and prior to (right).

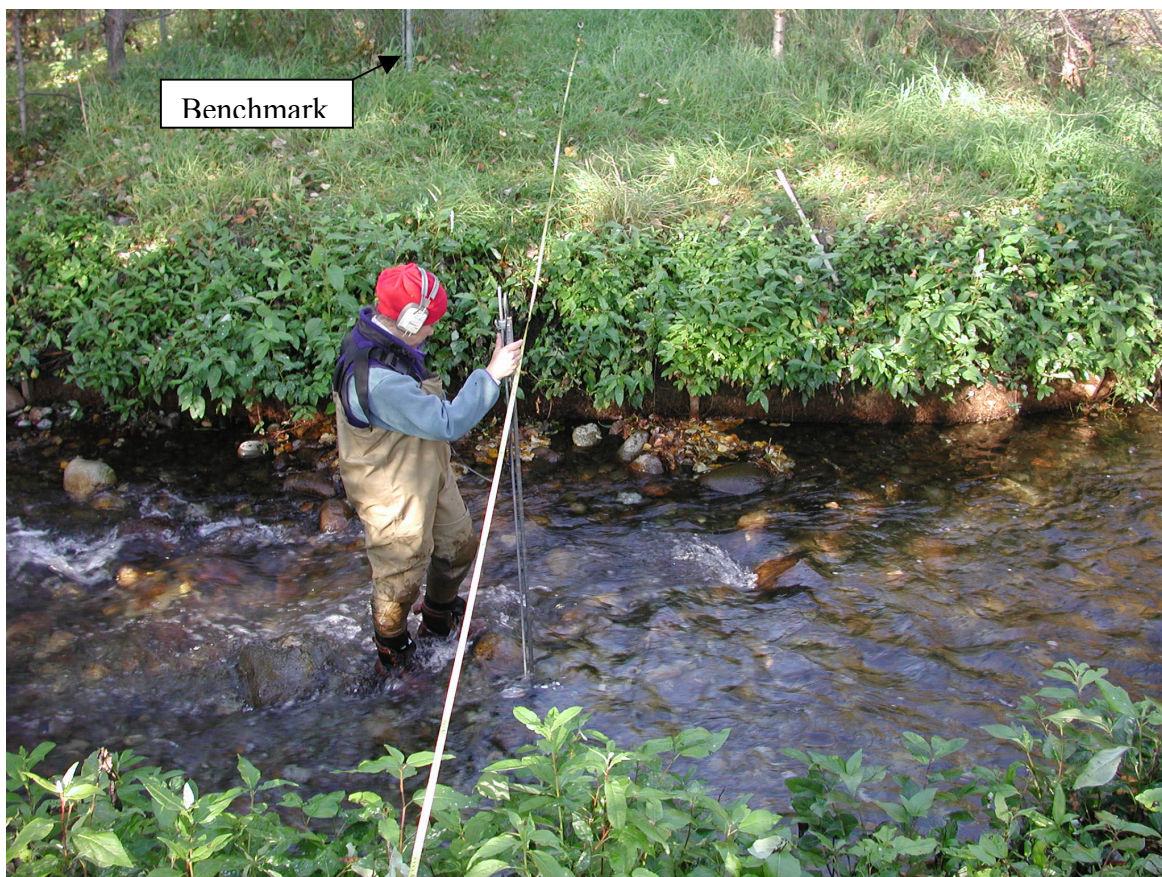
The unmodified riparian vegetation both upstream and downstream was composed of patches of closed (canopy of 60 to 100% cover) tall alder shrub and closed black cottonwood forest. Planted riparian vegetation was 100% cottonwood and extended 1-m laterally from ordinary high water (Figure A-4). The three-cottonwood brush layers extended vertically from ordinary high water to 0.7 to 0.8 m. Percent survival of the planted cottonwoods ranged from 70 to 90% 2-months following planting. Plant survival was lowest for the middle layer on both banks and may be due to a combination of elevation above OHW, soil compaction, and shading.

Figure A-4. Photograph of riparian vegetation at restored reach 2-months after culvert removal.

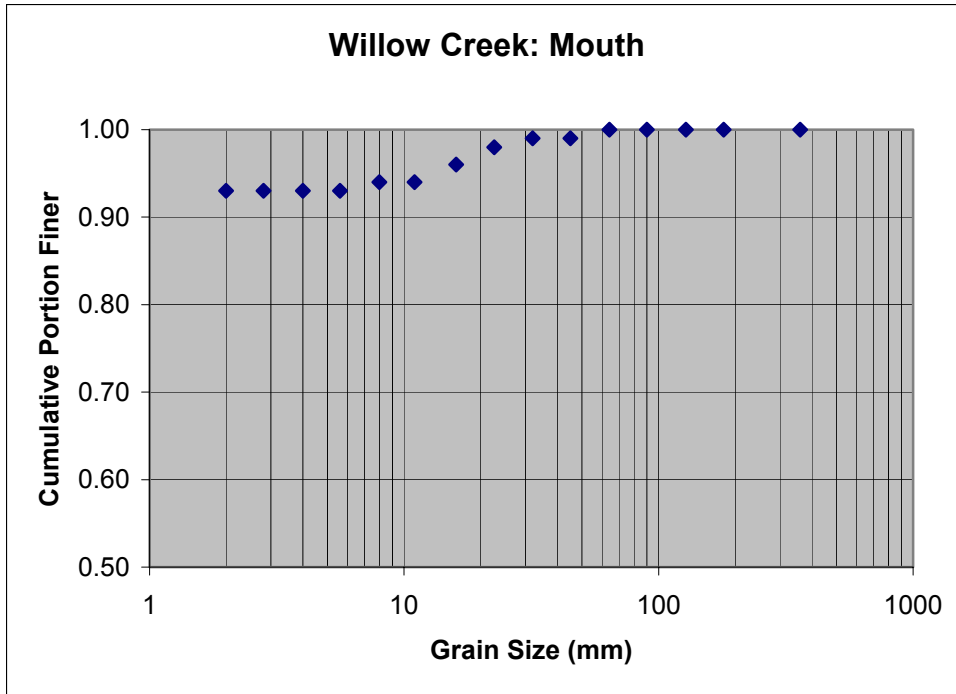
Figure A-5. Substratum size distribution at the mouth of Willow Creek showing dominant sand grain size.

Based upon observations and pre-project data project objectives must include stream bank stabilization and revegetation, increase in undercut banks and overhanging vegetation, and an increase in substratum size distribution. Bank stabilization and revegetation should accomplish most of these objectives. The reduction in sediment input from bank sloughing should result in stream-bed degradation and expose the underlying gravel substrate.

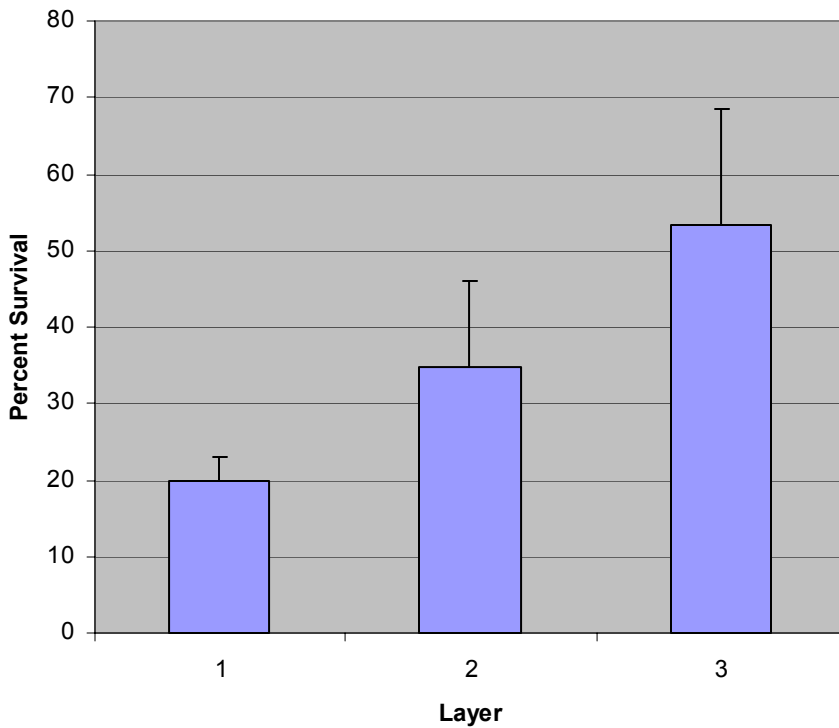
Figure A-8. Survival of planted willows for each brush layer in September 2001. Error bars are one standard deviation.

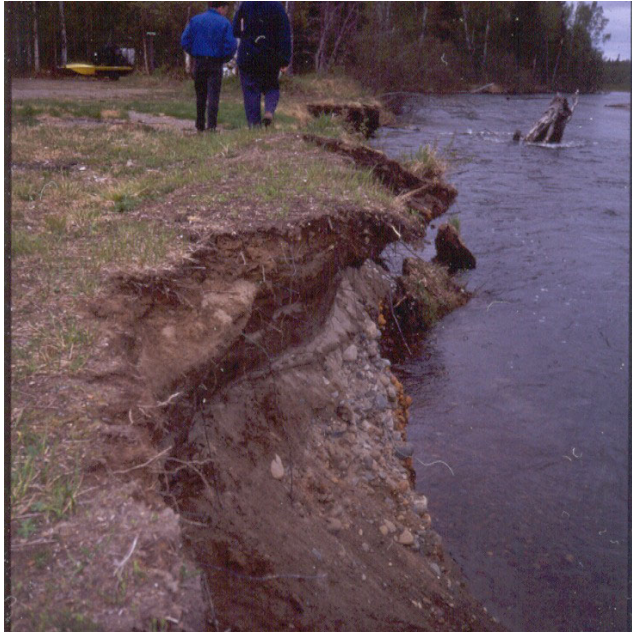
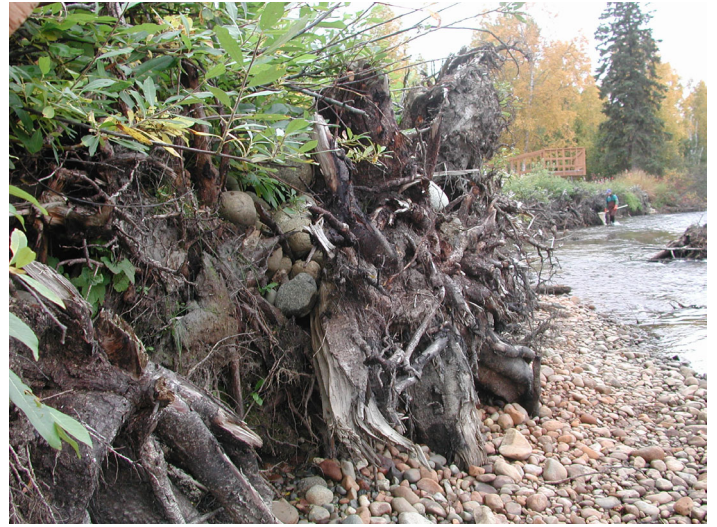
Figure A-9. Stream bank prior to and following implementation of restoration project showing road wad fans and stream substrate.

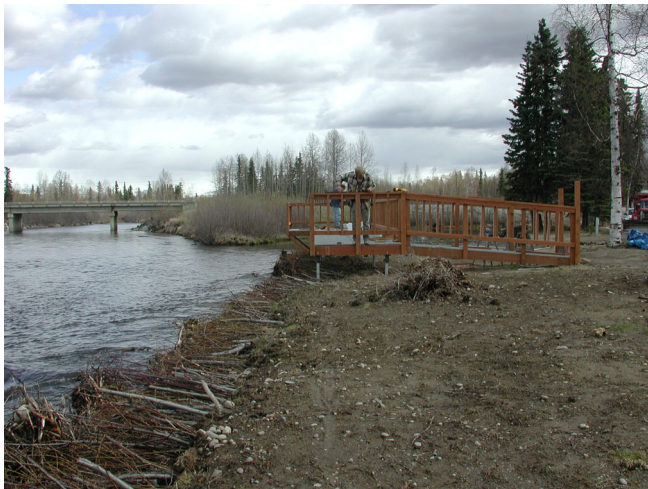
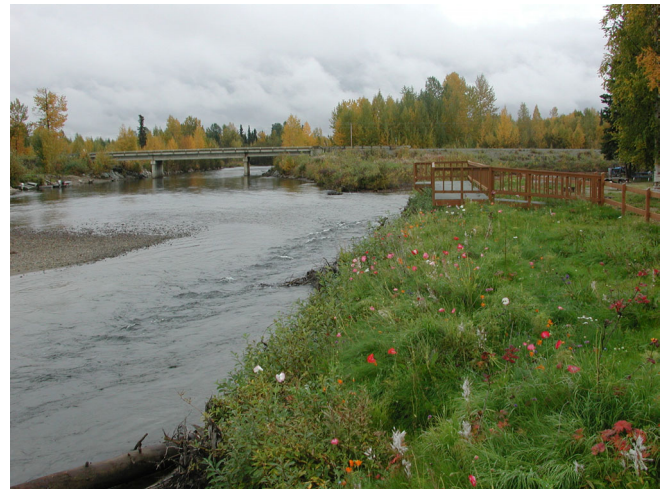
Figure A-10. View upstream from transect 3 just following project completion and in September 2001 showing first-season vegetation establishment.

The community composition of riparian vegetation, at this point, does not reflect natural conditions at distances greater than 2 meters from ordinary high water. At unmodified stream banks a zone of willows or alders is often observed and is reflected in the restored reach. However, greater than 2 meters an open birch forest predominates along Willow Creek, particularly at the drier sites, in contrast to the midgrass herb community in the restored section. Subsequent evaluations will document whether this area converts toward the reference riparian vegetation community.
