**Technical Report No. 12-06**

**Distribution of Resident Dolly Varden in Power Creek,  
Cordova, 2005-2007**

Alaska Department of Fish and Game  
Division of Habitat

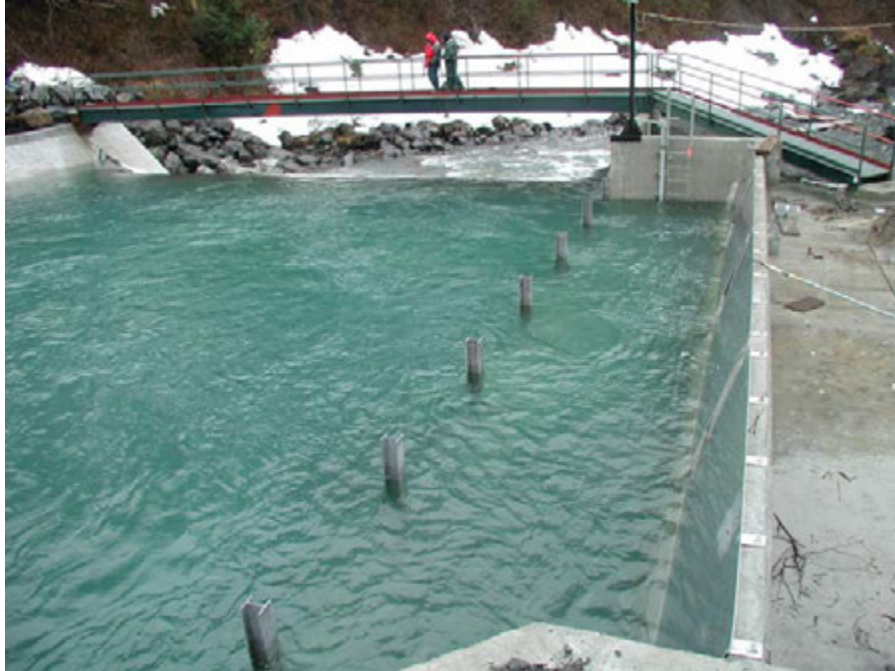
**Figure 3. Power Creek Hydroelectric Project intake structure.**

The Power Creek hydroelectric project is owned and operated by the Cordova Electric Cooperative (CEC) and consists of five primary components: a diversion dam and intake structure located at Power Creek stream mile 3.3, a tunnel and pipeline conduit conveying water about 5,900 ft, a powerhouse at stream mile 2.2 with an installed capacity of about 6 megawatts, a 7.2 mile buried transmission line, and about 2.5 miles of access roads (Figure 1). Construction began in 1998 and operation began in October 2001. The project is a “run of the river” design (i.e., minimal water storage capacity). The project diversion dam and intake is located about half a mile upstream of Ohman Falls, which is a barrier to upstream fish migration. The dam consists of concrete abutments with a 50 ft. by 8 ft. inflatable bladder that can impound a forebay of about 0.07 hectares (Figure 2). The surface water level and forebay depth are controlled by the inflation or deflation of the bladder as power demand and streamflow fluctuate. Streamflow that is greater than project capacity or power generation needs spills over the diversion dam. There is a minimum 5 cubic feet per second (cfs) instream flow requirement immediately downstream of the diversion dam. The water intake is located immediately upstream of the diversion dam on the north abutment and contains vertical trash rack bars of 1.5-inch spacing and a sediment retention wall to prevent bedload intake (Figure 3). The dam bladder is periodically deflated to allow streamflows to flush any sediment accumulation immediately upstream of the dam and maintain downstream sediment transport. Operational flushing event frequency depends on streamflow and may occur daily during high flow periods or up to three months may pass during low flow periods (Clay Koplín, CEC, personal communication). After conveyance to the powerhouse (Figure 4), water is returned to Power Creek via an open channel tailrace about 60 ft long, 30 ft wide, and 5 ft deep (Figure 5).

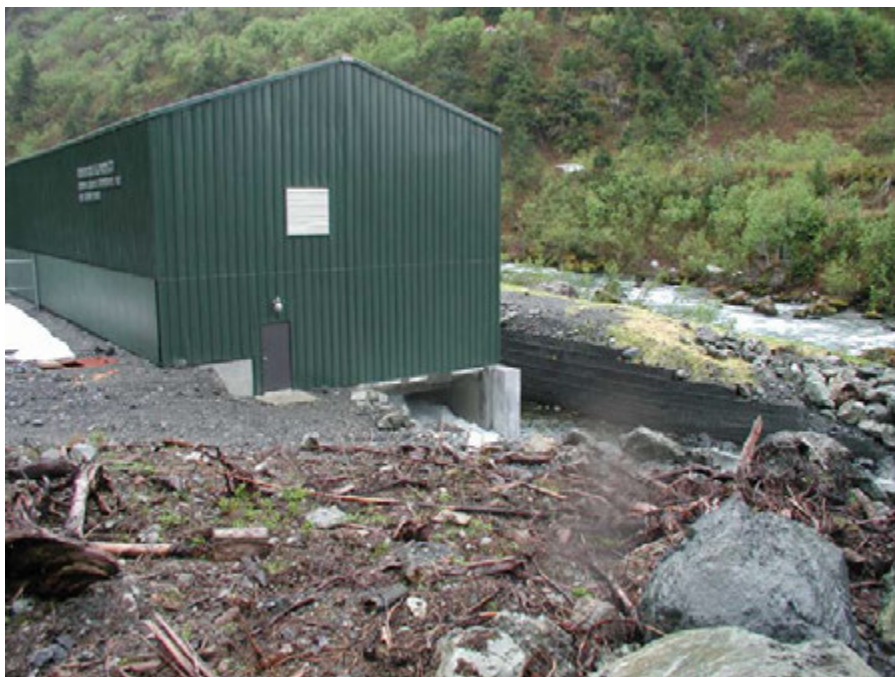
**Figure 4. Power Creek Hydroelectric Project power house.**

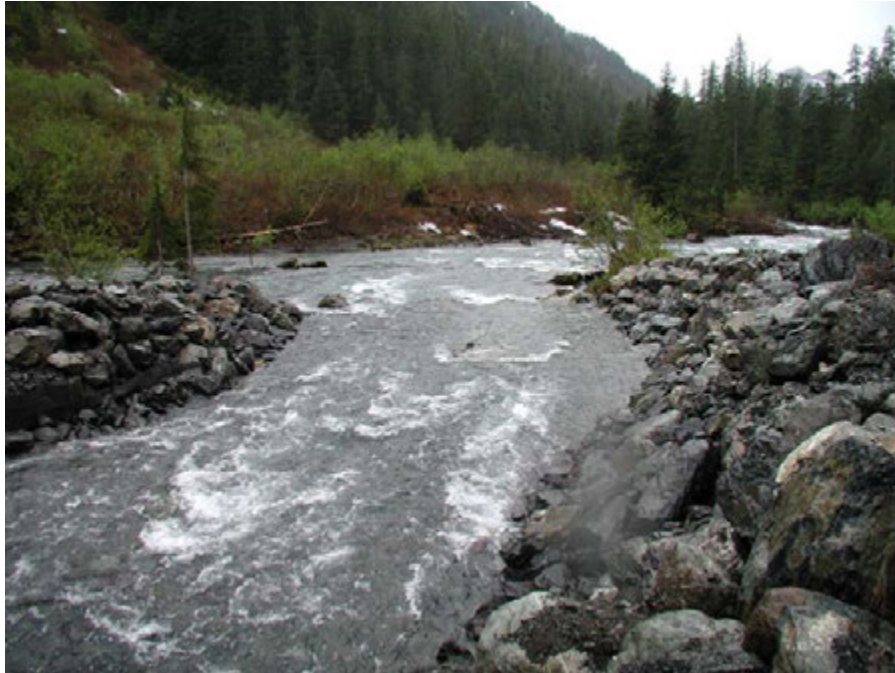
**Figure 5. Power Creek Hydroelectric Project open water tailrace.**

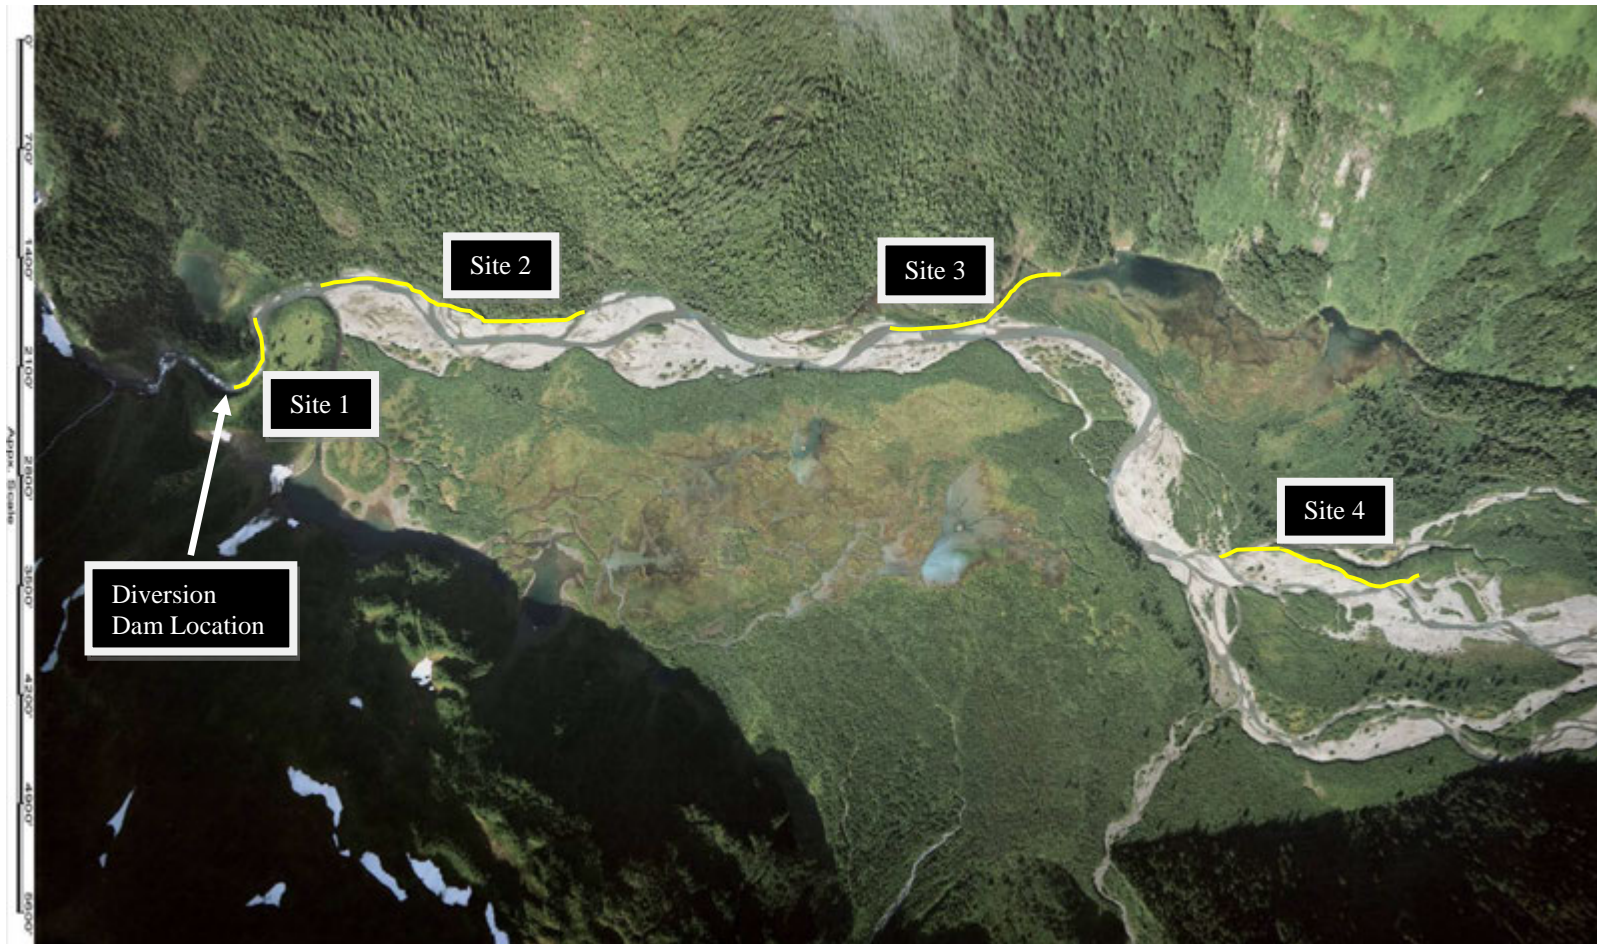
**Figure 6. Study area in upper Power Creek above Ohman Falls. Four sites were sampled upstream of the diversion dam.**

The study area is located on Power Creek, a glacially influenced tributary to Eyak Lake northeast of Cordova, Alaska. About 12.8 river kilometers of resident fish habitat exist upstream of Ohman Falls. Power Creek flows through an alluvial valley of glacial deposition with braided channels at the top of the study area and becomes confined and steeper within 1.6 km of Ohman Falls. The study area included four sampling sites upstream of the project diversion dam and within 3.2 km of Ohman Falls (Figure 6). Site 1 was located immediately upstream of the diversion dam extending about 150 m upstream. Site 2 and 3 were located 465 – 815 m and 1,540 – 1,890 m upstream of the diversion dam and contained access to beaver ponds. Site 4 was the farthest upstream of the diversion dam between 2,620 – 2,970 m.

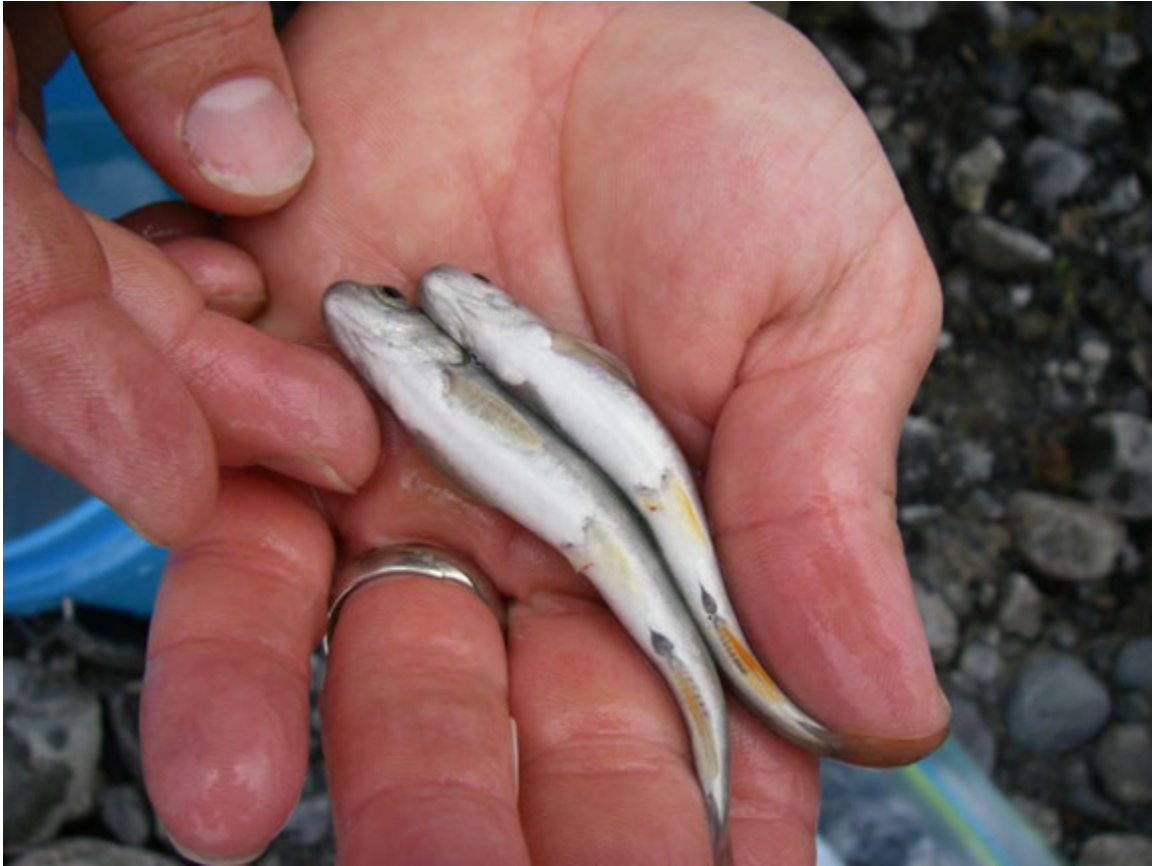
**Figure 7. Dolly Varden with a left pelvic fin clip.**

Traps were recovered 24 hours later and fish were anesthetized with Alka-Seltzer (half tablet per liter of water), measured to the nearest millimeter (fork length), marked with a fin clip, and released at the point of capture. To monitor movement patterns, fish were marked with four distinct fin clips (i.e., Site 1 – lower caudal lobe, Site 2 – upper caudal lobe, Site 3 – left pelvic fin, and Site 4 – right pelvic clip; Figure 7).

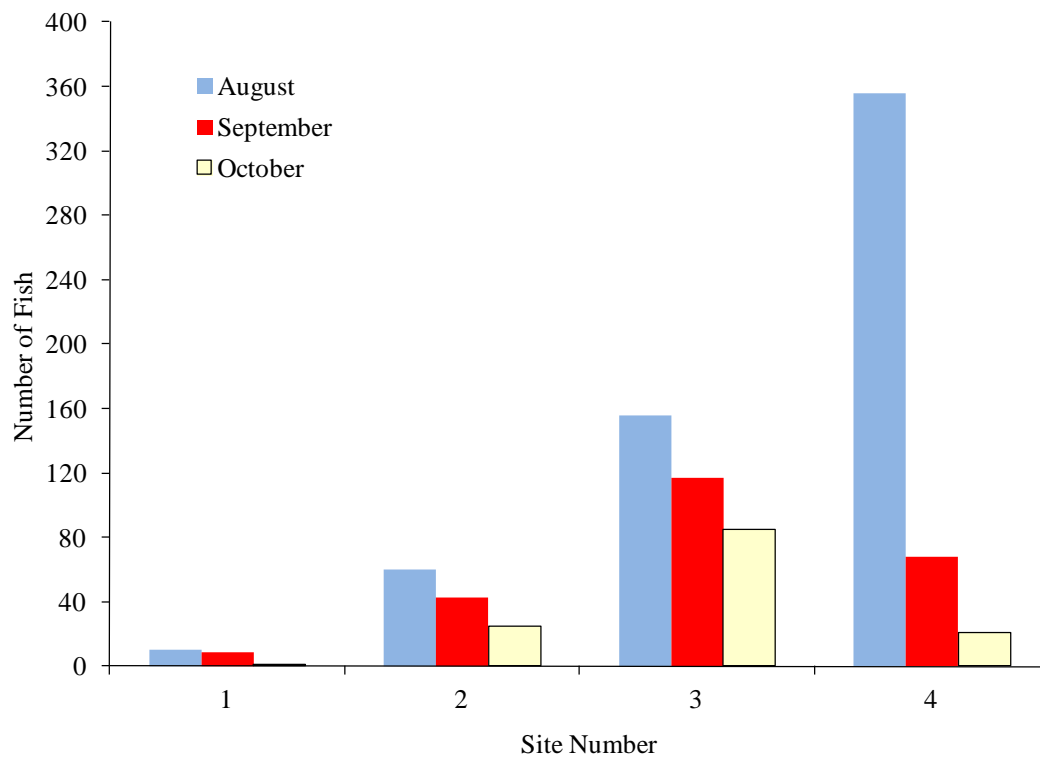
**Figure 8. Dolly Varden catch by month and site, 2005.**

Dolly Varden were the only fish captured in the study area. In general, catches were highest earlier in the season and at the uppermost sites (i.e., Sites 3 and 4; Table 1; Figure 8, Figure 9, and Figure 10). Catch per unit of effort (number of fish per trap hour) ranged from 0.00 to 1.48 (Table 2). Similar to catch, CPUE was highest early in the season and at the upstream sites.

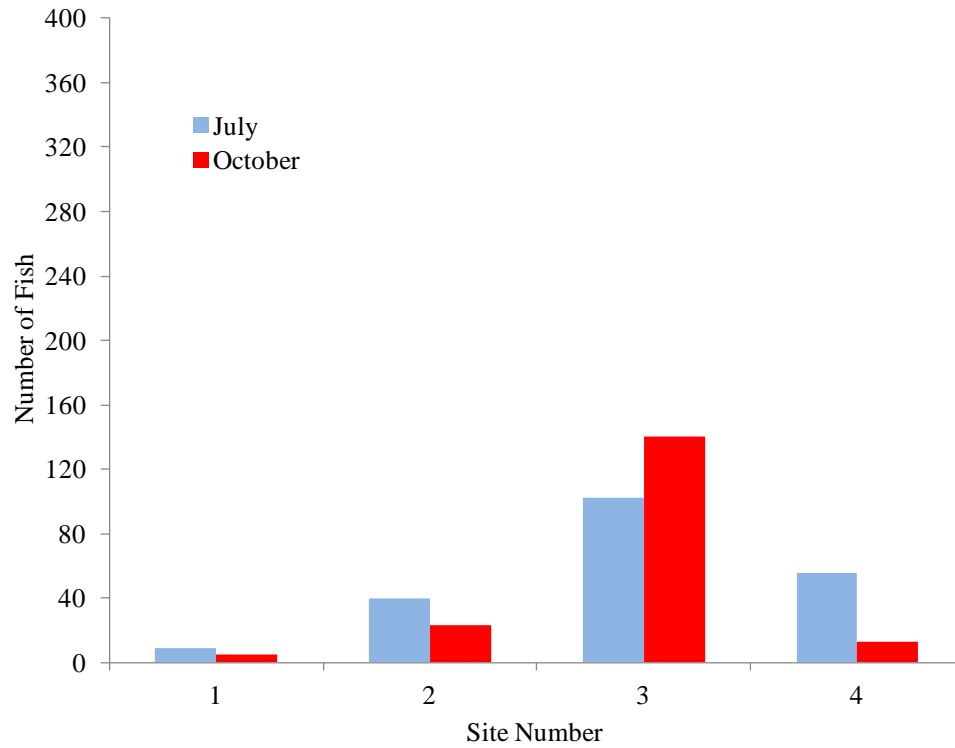
**Figure 9. Dolly Varden catch by month and site, 2006.**

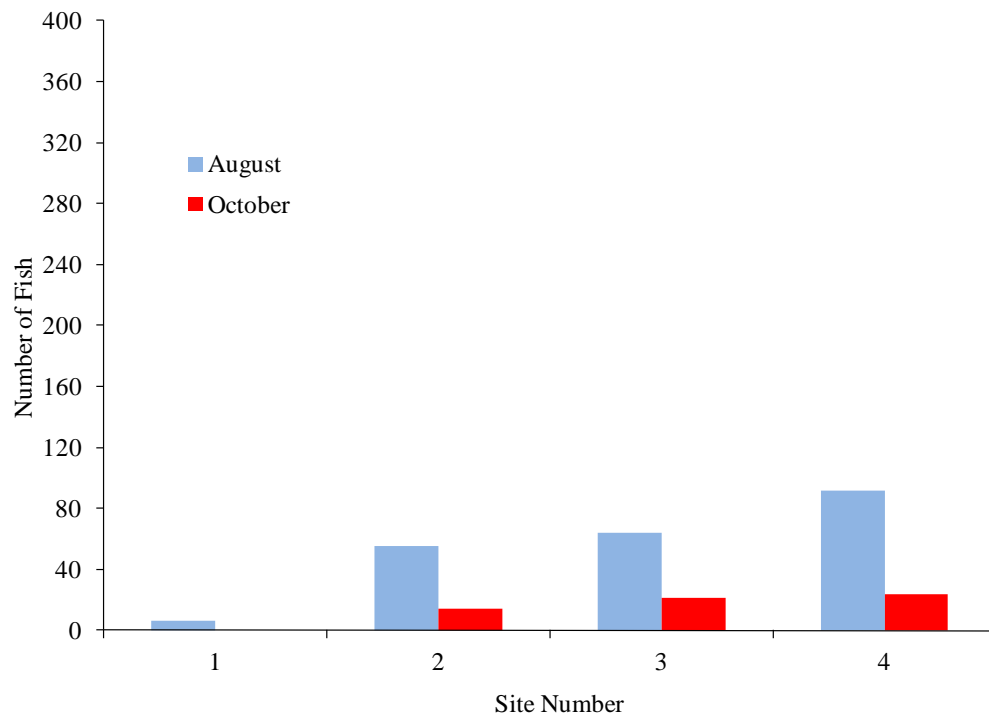
**Figure 10. Dolly Varden catch by month and site, 2007.**

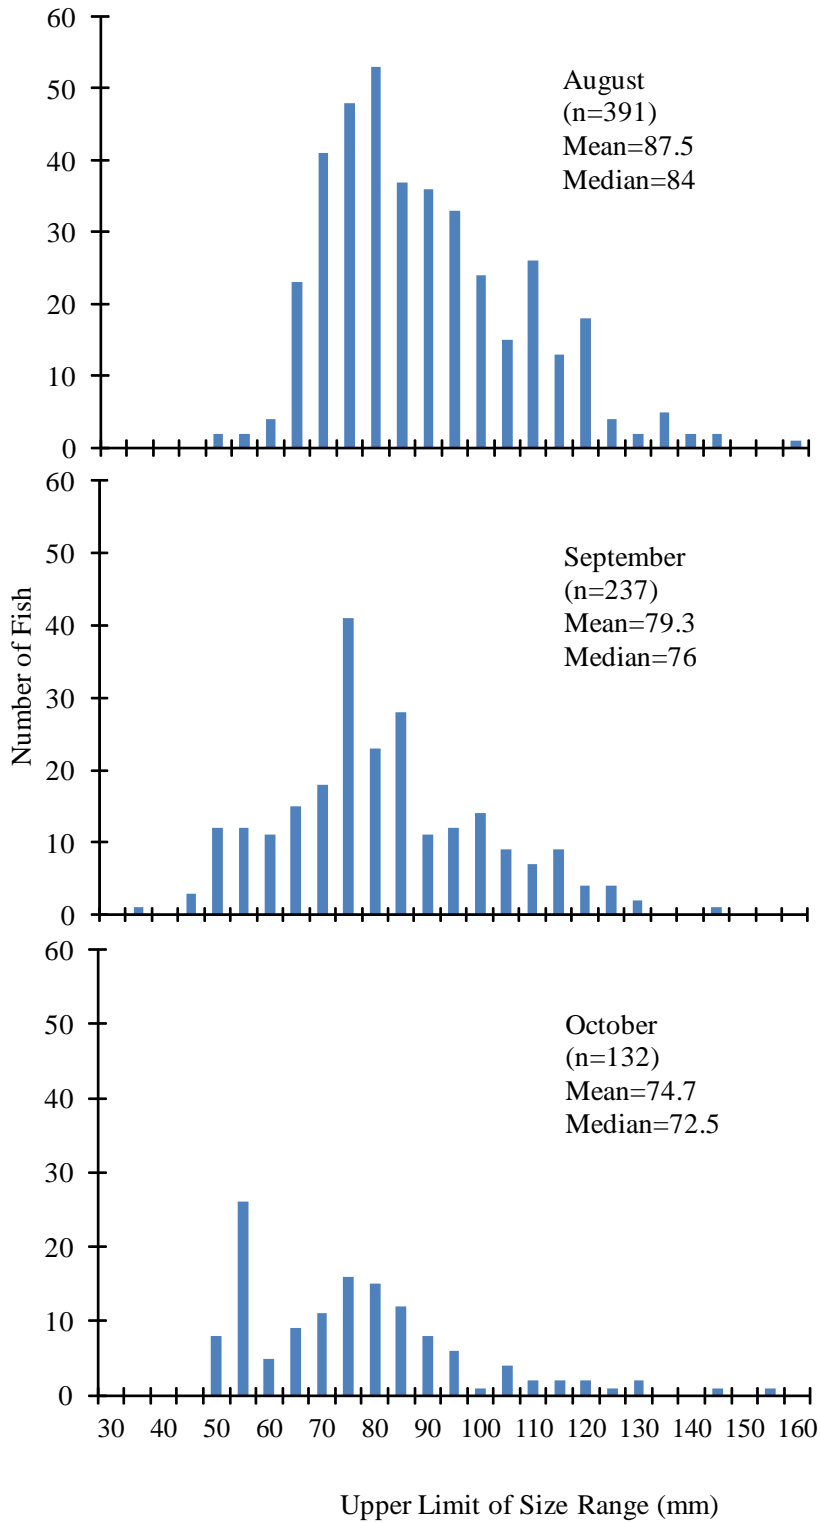
**Figure 11. Dolly Varden length frequency distribution, by month, 2005.**

Dolly Varden lengths ranged from 34 to 175mm, with most fish between 60 and 100mm (Figure 11, Figure 12, and Figure 13). In each year, mean length in the study area decreased over time; larger fish appeared less abundant in the October sampling event (Figure 11, Figure 12, and Figure 13). Month-specific (August and October) length frequency distributions were similar among years (using the July 28 sample in 2006 as a surrogate for August). The August and October mean lengths were also similar among years (August:  $F=7.55$ ,  $p=0.0006$ ; October:  $F=8.59$ ,  $p=0.0002$ ). The mean length of Dolly Varden was highest in the lower portions of the study area (Sites 1 and 2) relative to the upper parts of the study area (Sites 3 and 4; Figure 14); however, this result may be a function of sample size.

Based on length frequency distributions (Figure 11, Figure 12, and Figure 13), there appears to be a decrease of larger fish in the Power Creek October samples. This suggests a possible Dolly Varden spawning migration to Power Creek habitats above the study area. While more information would be required to verify this theory, the idea is consistent with observations elsewhere (Bryant and Lukey 2004, Bryant et al. 2009). Further, a possible spawning migration during this time of year correlates with declining water temperatures (Sea-Run Fisheries 2003a, 2006a, 2007, 2008, 2009, 2010); more data are needed to determine if this observation is coincidental or if declining temperatures trigger upstream movement to likely spawning areas.

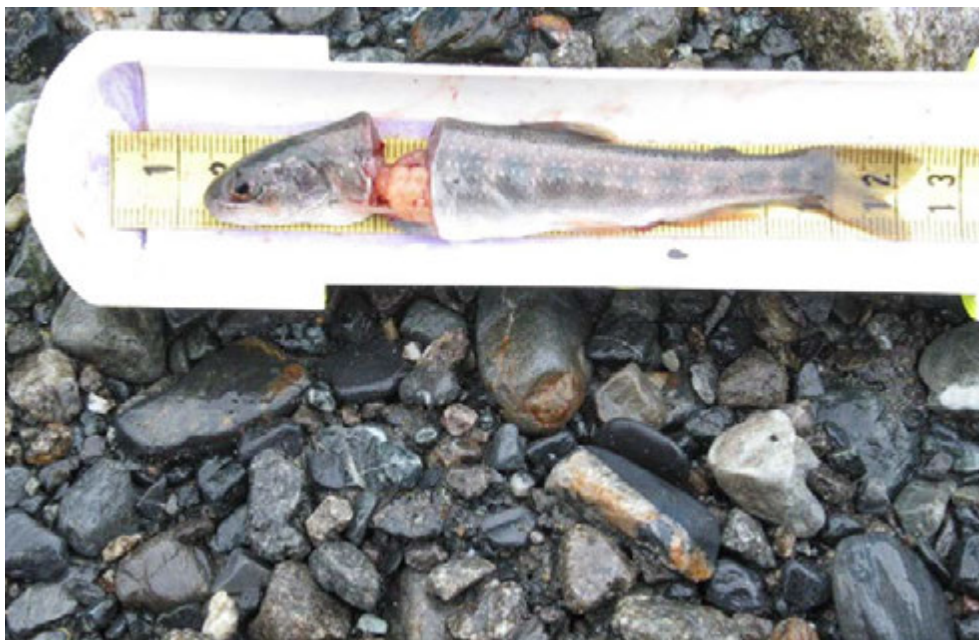
**Figure 15. Female Dolly Varden (94mm) in near spawning condition on October 11.**

We observed a difference in the coloration of the fins and spots between fish smaller and larger than about 90 mm. A white anterior ray of the pelvic fin of large fish was often followed by dark fin rays compared to semi-transparent or faint orange fins on the smaller fish. White spots were noted on the sides of larger fish compared to large parr marks and less prominent spotting on smaller fish. To examine sexual maturity, one female (94 mm) was sacrificed and found to be near spawning condition on October 11, 2005.

However, we suspect the apparent smaller size of Power Creek Dolly Varden is a result of sampling gear bias and sampling area, rather than an actual difference in lengths; additional information would be required to test this hypothesis. Stream-dwelling resident chars typically reach sexual maturity at a smaller size and younger age than either anadromous or lake-dwelling resident chars. Many anadromous Dolly Varden in Southeast Alaska matured at age 5 (Heiser 1965, Blackett 1973, Kruger 1981); reported lengths indicate these fish were about 300 mm. Similarly, McPhail and Murray (1979) reported that Dolly Varden residing in Upper Arrow Lake for most of their adult life migrated into the spawning tributary Mackenzie Creek at age 4 and 5. For stream-dwelling resident char populations, Gregory (1988) reported Tiekel River (Southcentral Alaska) Dolly Varden spawning as early as age 2 and Morita and Morita (2002) reported white-spotted charr (*S. leucomaenis*) in the Hitozuminai River (Hokkaido) spawning at age 1+, while Blackett (1973) reported Falls Creek (Southeast Alaska) Dolly Varden spawning at age 3. Length at spawning for these resident char studies ranged from 130 to 220 mm; the single Power Creek Dolly Varden sacrificed and determined to be near spawning condition was 94 mm (Figure 15).
