**Technical Report No. 13-04**

# **Documenting Anadromous Water Bodies Southeast Alaska**

Alaska Department of Fish and Game

Division of Habitat

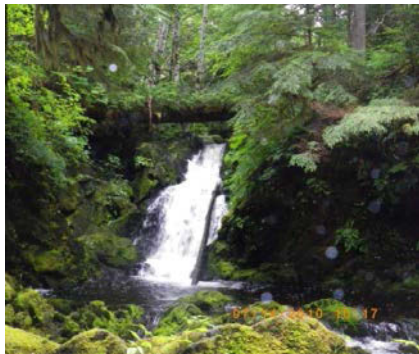
Figure 5.—Barrier falls on Bessie Creek.

Waypoint	Latitude	Longitude	Notes	Sample Effort	Sample Results
1	58.5903	-134.9020	Tracking above the tide line.	RS	
2	58.5924	-134.9030		RS	
3	58.5928	-134.9020	16 - 20 foot barrier falls.	RS	
4	58.5934	-134.9000	Upper barrier falls. Beauty.	RS

**Recommendations:** Update the stream route in the AWC.

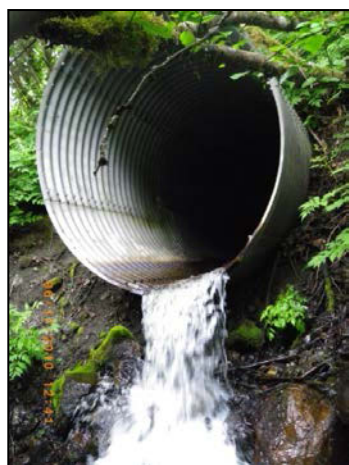
Figure 14.–Perched culvert on Falls Creek.

Waypoint	Latitude	Longitude	Notes	Sample Effort	Sample Results
6	58.3228	-134.4825	Set trap 75' above culvert, below 4' falls created by large woody debris.	MT	3 DV
7	58.3234	-134.4818	Inside mouth of 90' culvert with 8% gradient and a 5.5' perch.		
8	58.3232	-134.4819	Base of perched culvert with large boulders beneath, and 2' deep plunge pool.		
9	58.3237	-134.4814	Begin track log in lower extent of stream.

**Recommendations:** Update the stream route in the AWC to reflect the shortened route and culvert barrier. Continue to investigate lower portion of stream for anadromy.

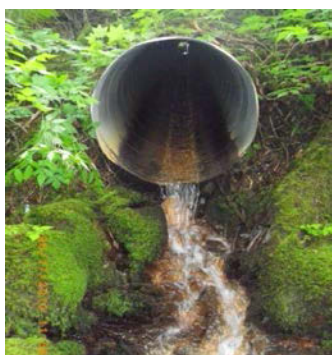
Figure 17.—Perched culvert outlet.

Waypoint	Latitude	Longitude	Notes	Sample Effort	Sample Results
1	58.3039	-134.4494	Begin trackline at mouth of stream where it empties out into the wetlands.	RS	
2	58.3039	-134.4496	Base of bedrock reach 30-feet long, 15% gradient.	RS	
3	58.3038	-134.4498	End of bedrock stretch, large boulders and cobbles. Good rearing but not spawning habitat.	RS	
4	58.3034	-134.4502	Outlet of culvert that crosses under North Douglas Highway. Stream maintains a 15% gradient from bedrock reach to inlet of culvert.	RS	
5	58.3033	-134.4508	Inlet of culvert. Stream bed is 2 feet higher than culvert inlet. strange placement.	RS

**Recommendations:** Update the stream route in the AWC. This culvert would be a good one for replacement someday.

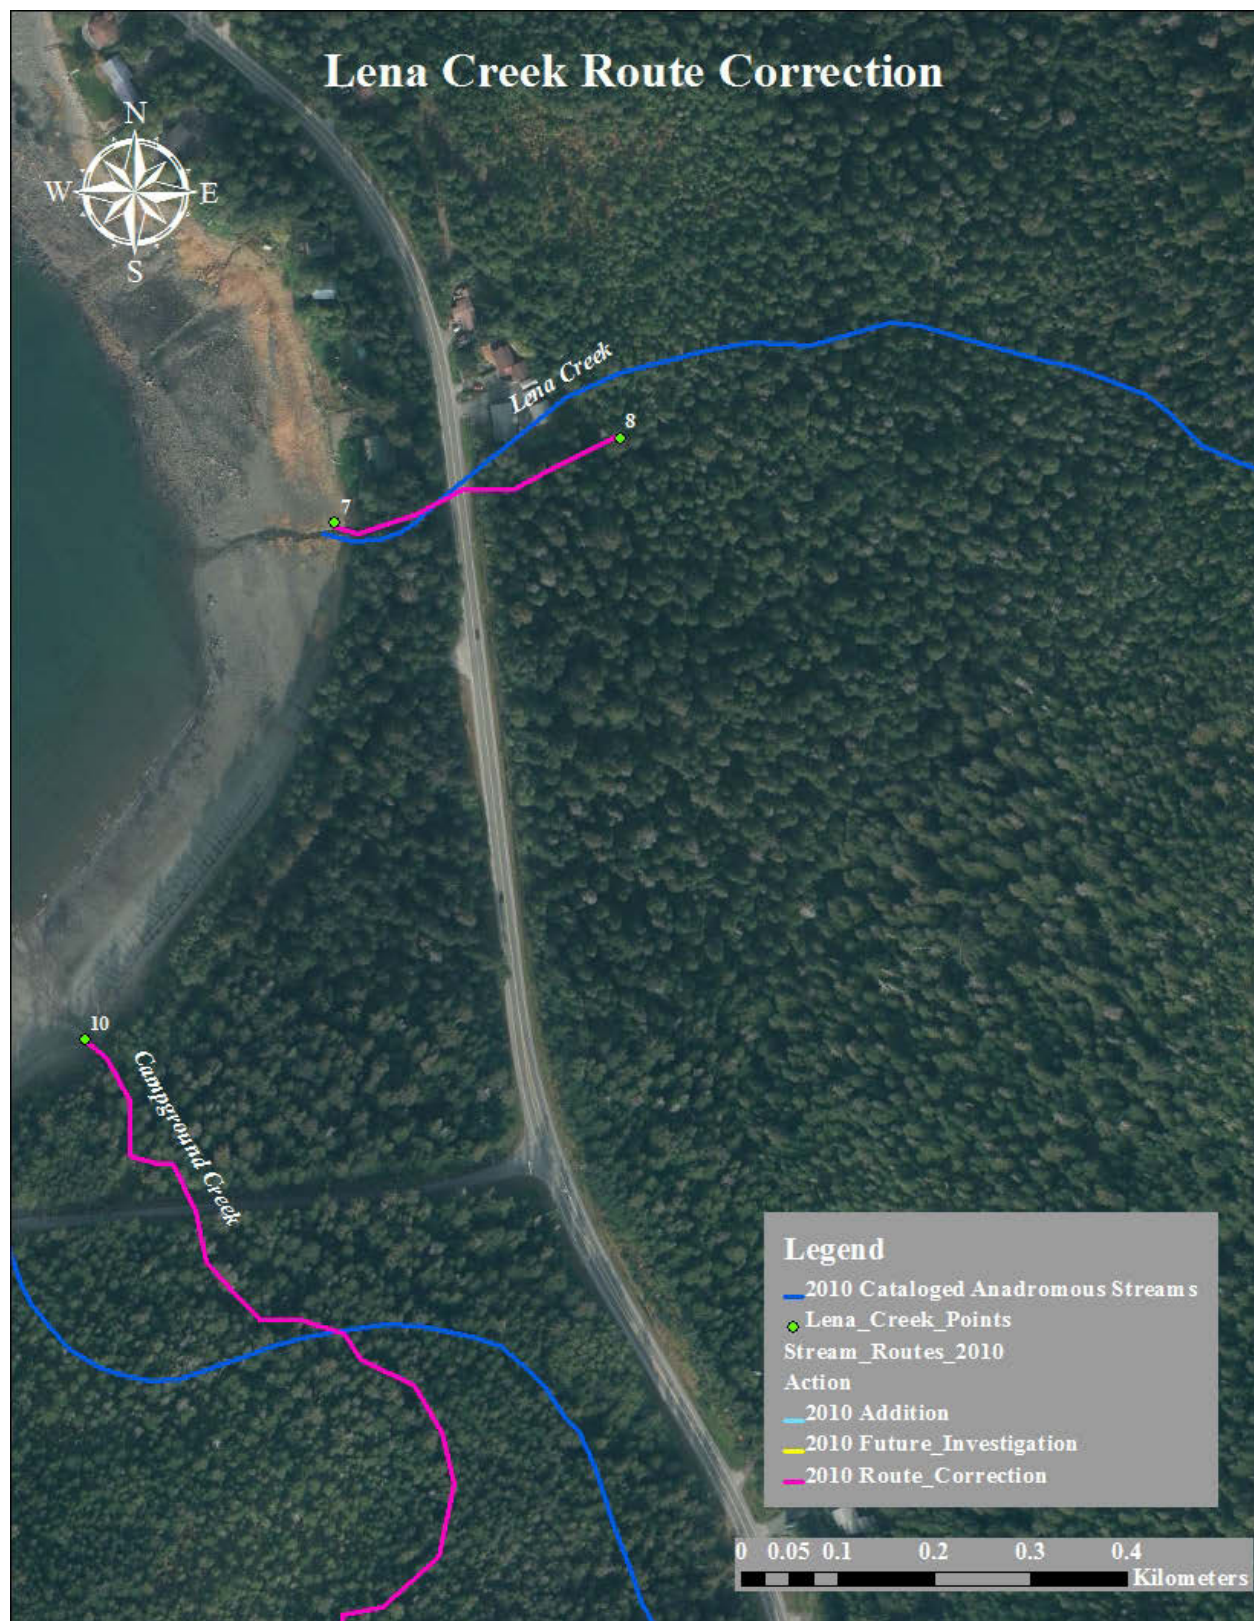
Figure 33.—Lena Creek route correction map.

Waypoint	Latitude	Longitude	Notes	Sample Effort	Sample Results
7	58.3955	-134.7485	Begin track log in tidal zone.	RS	
8	58.3959	-134.7458	End of track and anadromy. Huge bedrock waterfall. 45-50 % gradient. Approximately 140' long.	RS

**Recommendations:** Update this stream in the AWC by shortening the cataloged length to stop at the waterfall.

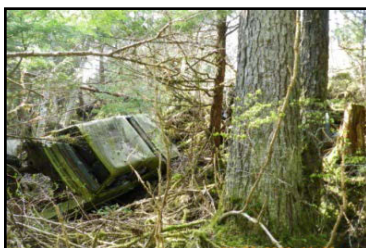
Figure 49.—Old car dumped in Shrine Creek.

**Findings:** The upper extent of anadromy extends past the cataloged upper limit. We captured juvenile CO and P and found an old car. The stream does not pass under the Glacier Highway at the location in the catalog. It passes through a culvert under the highway farther up the road. The following table and map provide additional data on the route correction.

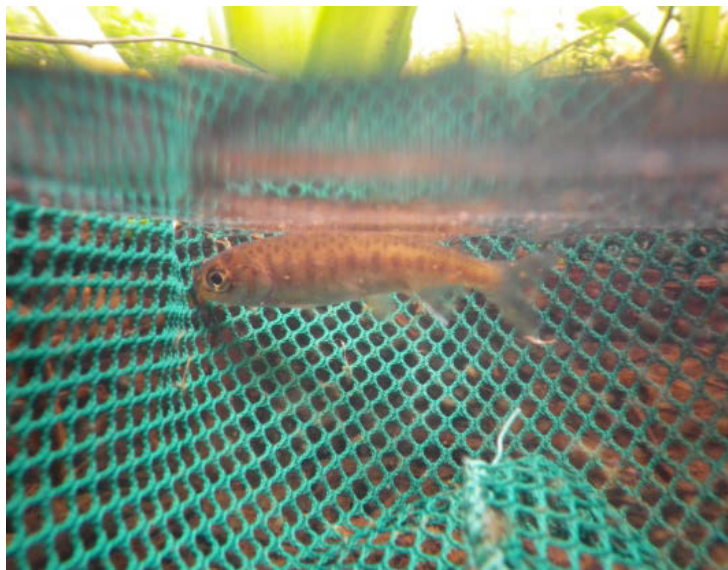
Figure 85.—Coho salmon captured in Little Coho Creek tributary.

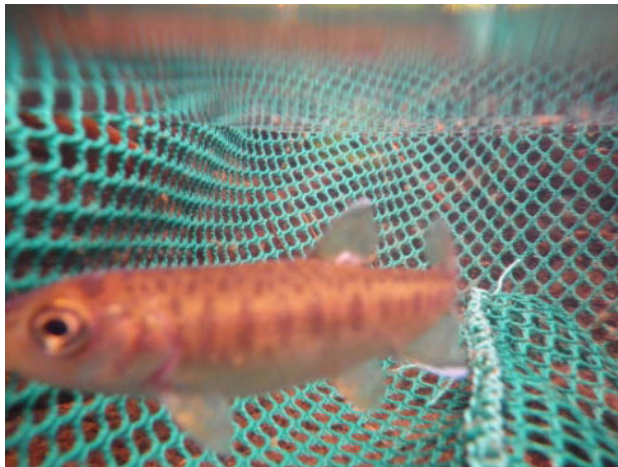
Figure 87.—Coho salmon captured in 5 Mile Creek.

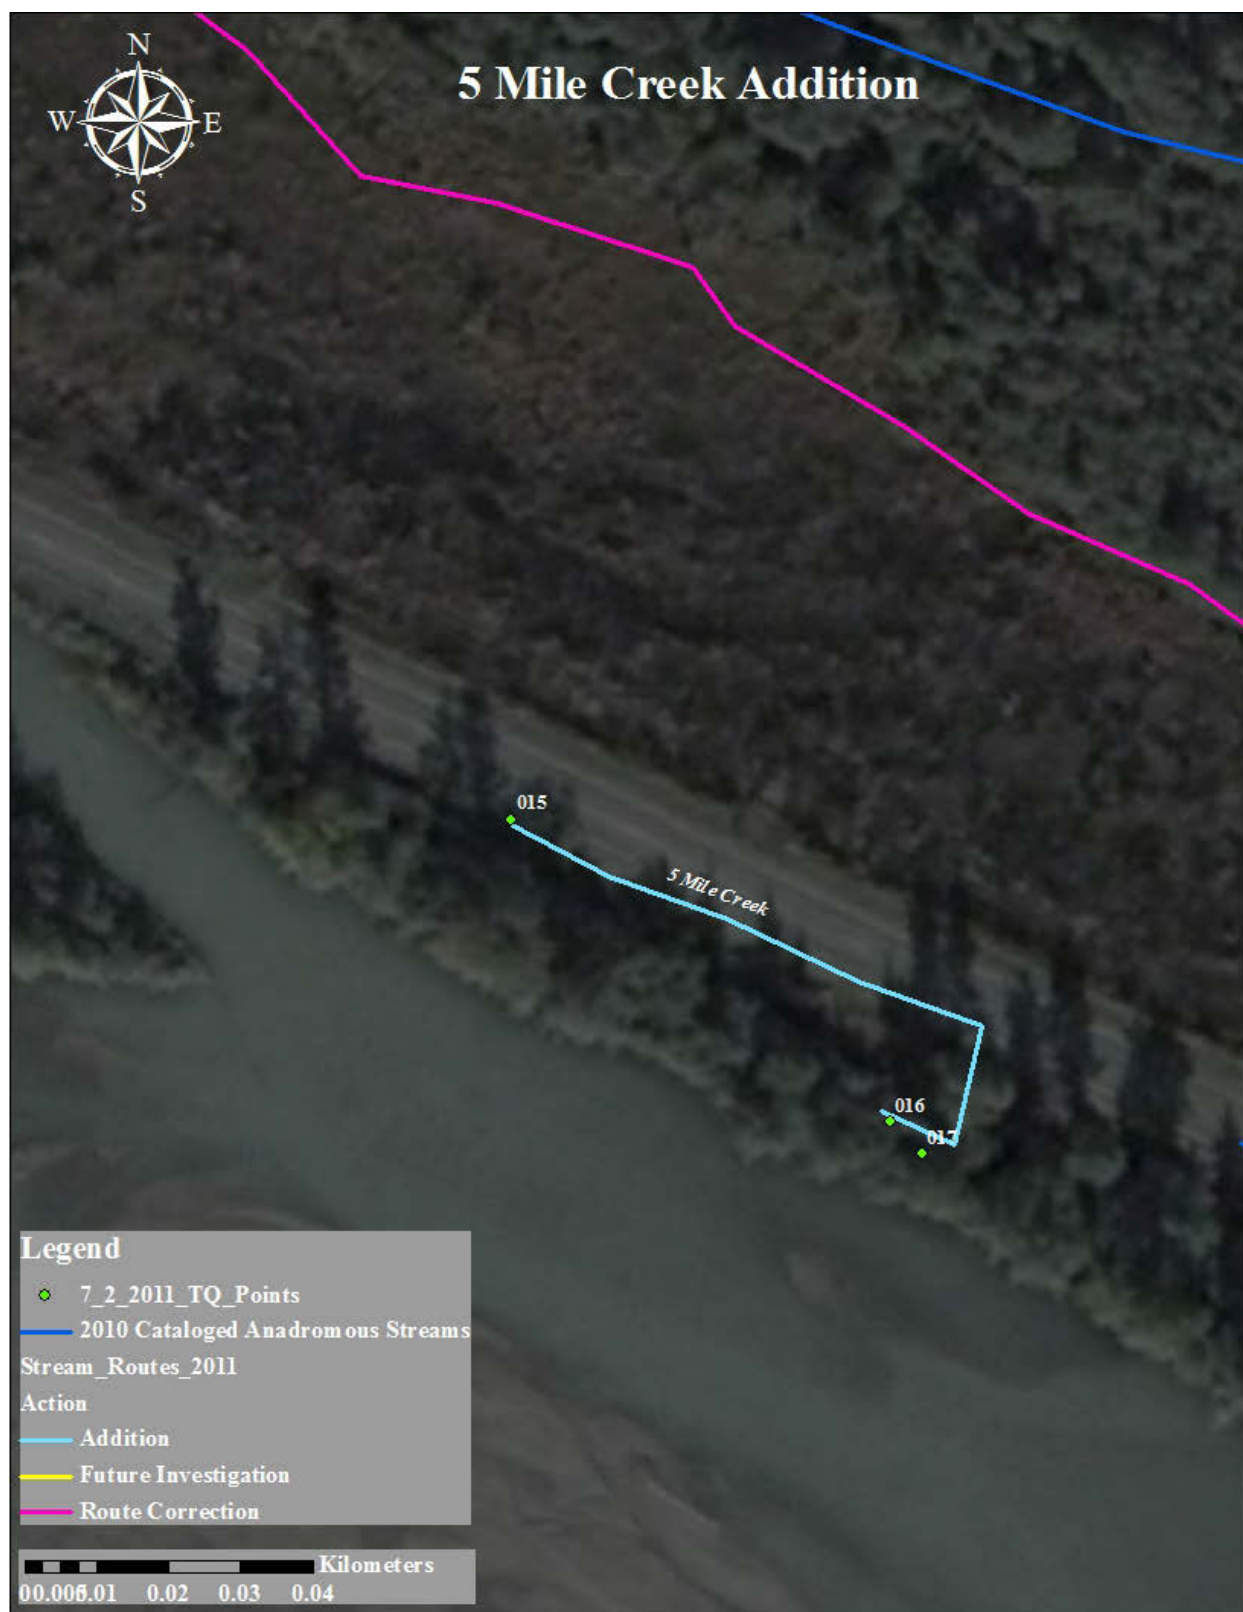
Figure 88.—5 Mile Creek addition map.

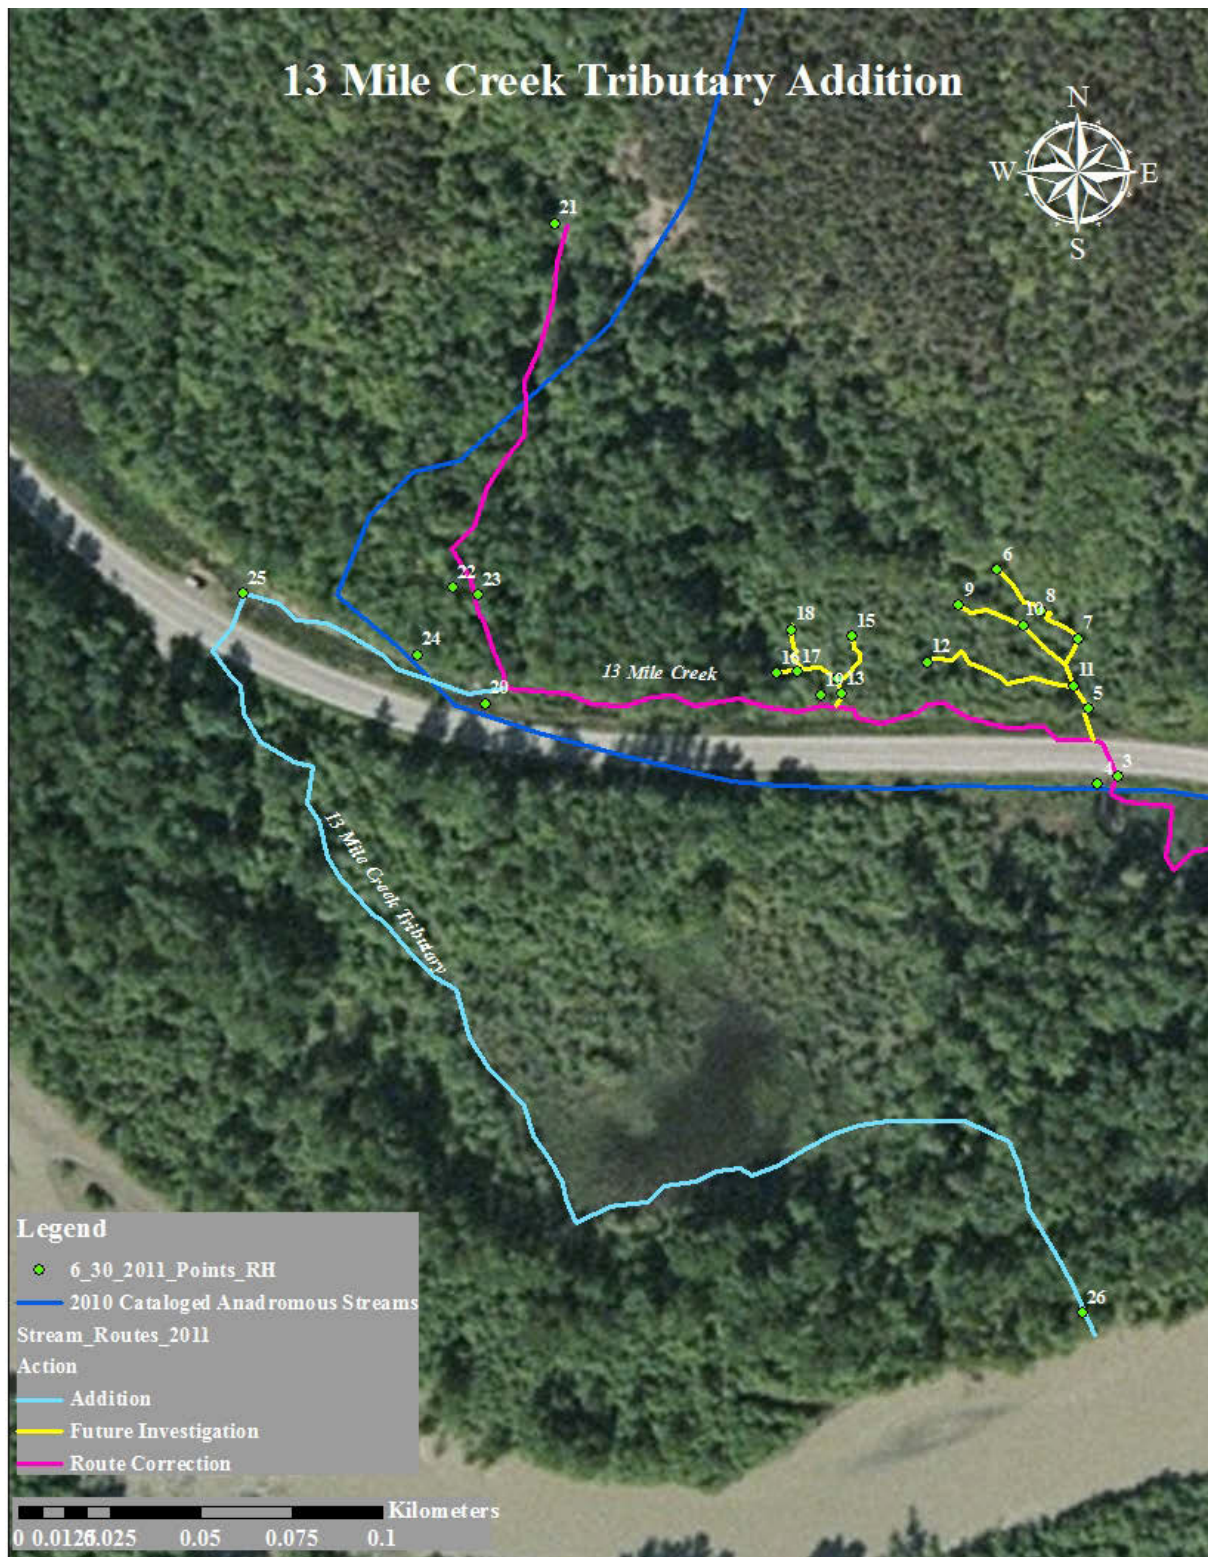
Figure 96.—13 Mile Creek tributary addition map.

**Recommendations:** Add this stream to the AWC.

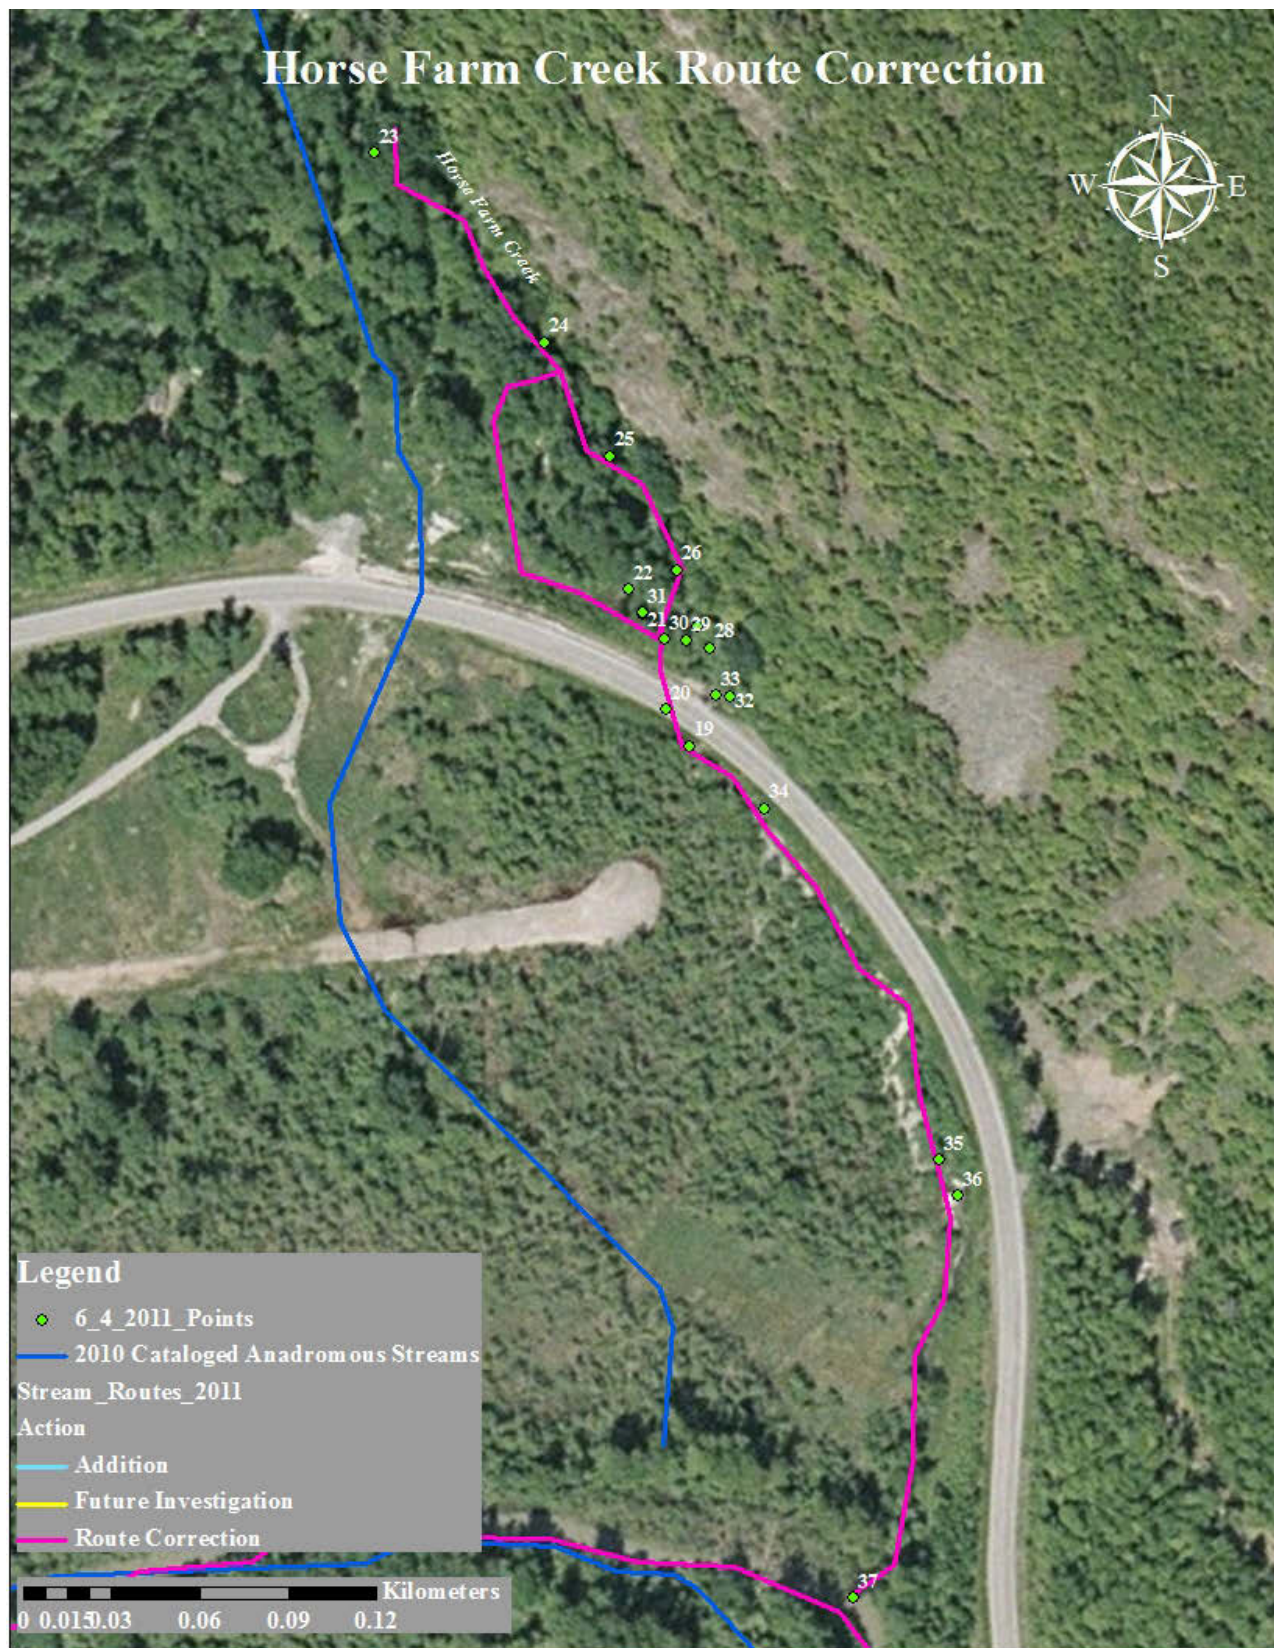
Figure 99.—Horse Farm Creek correction map.

**Recommendations:** Update this stream's route, upper, and lower limit in the AWC.

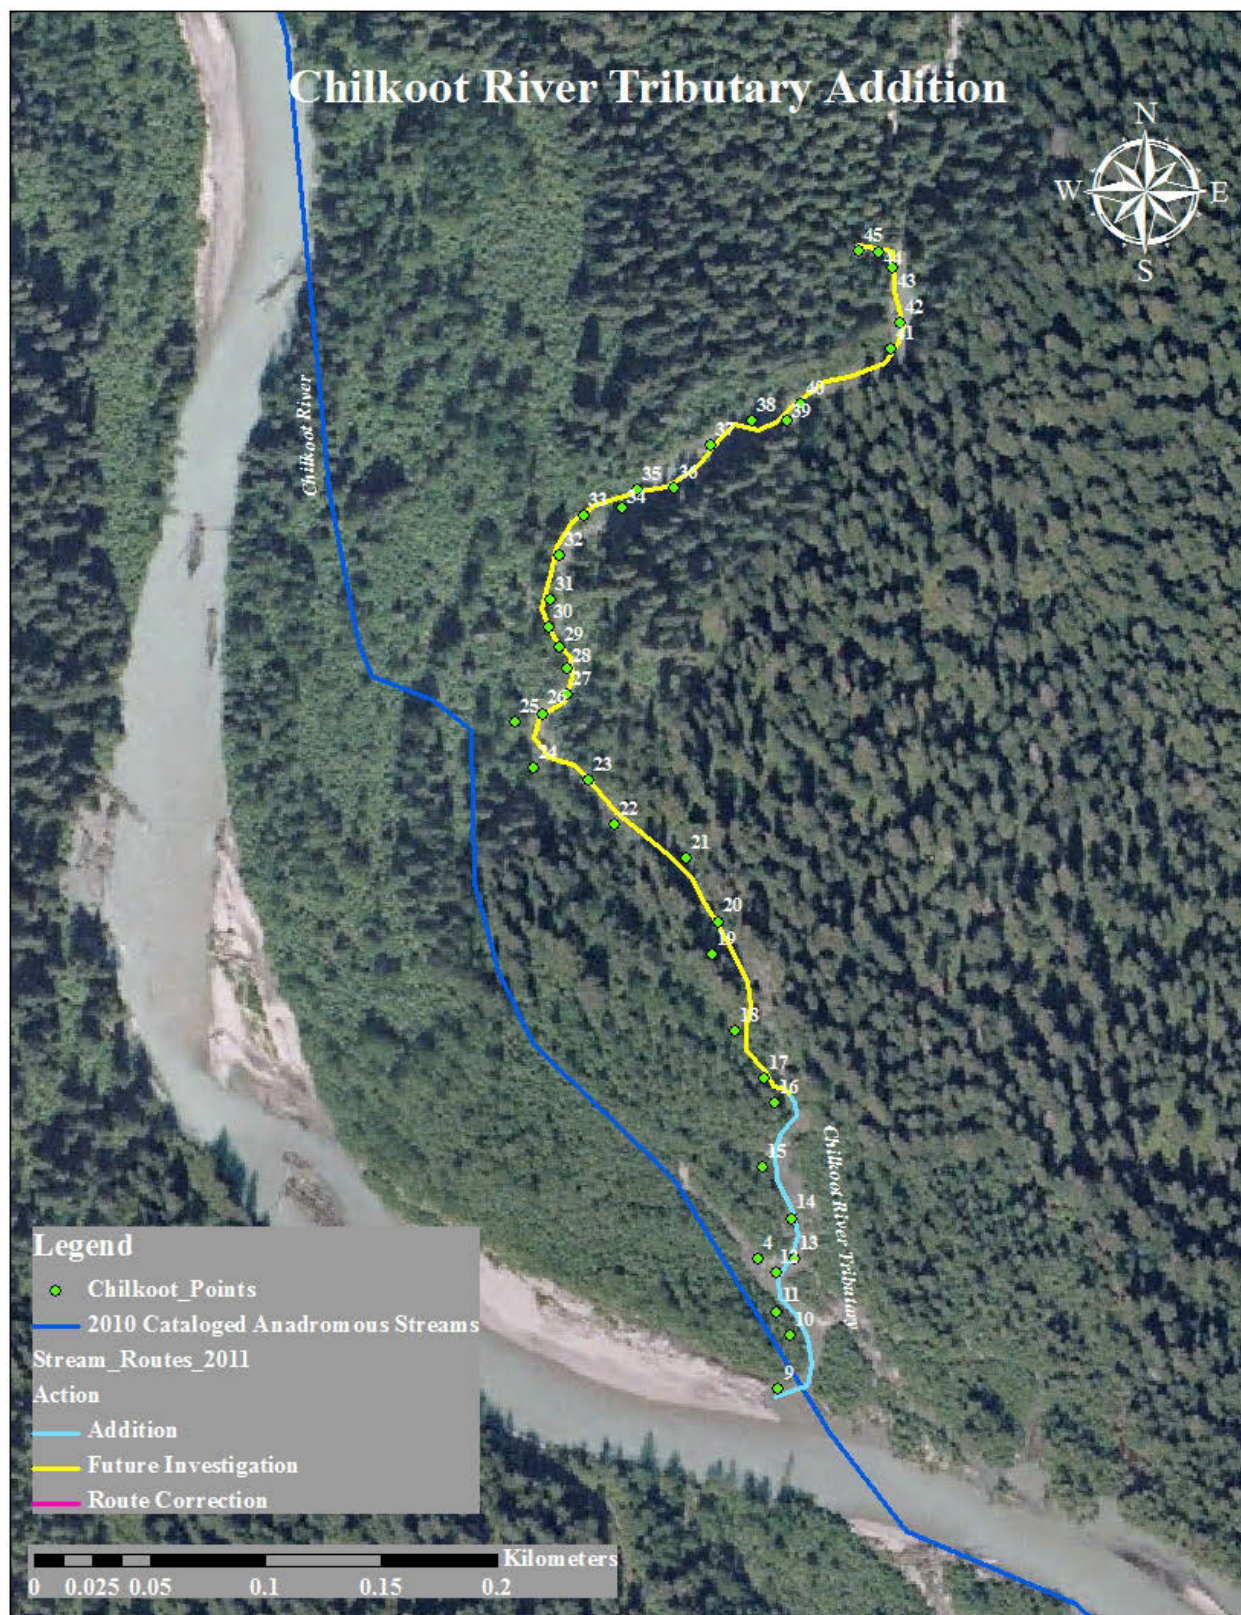
Figure 113.—Chilkoot River tributary addition map.

**Recommendations:** Add the lower section of this stream to the AWC.

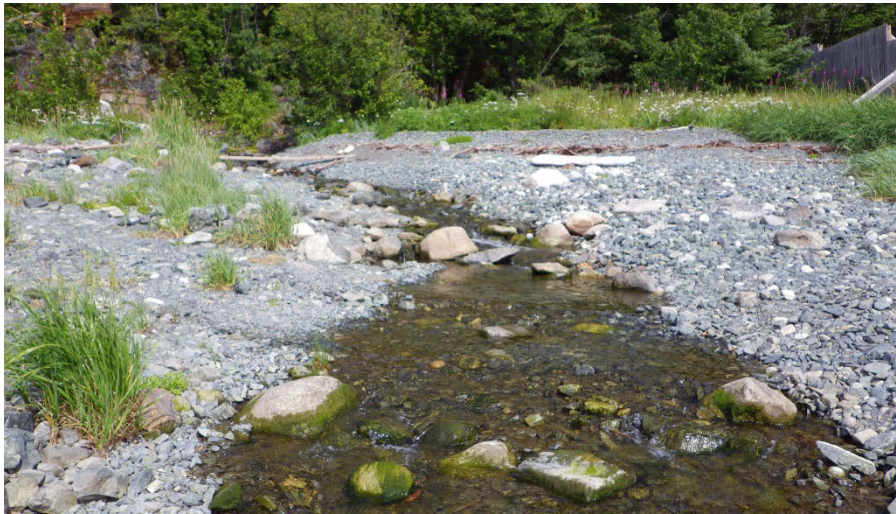
216	59.1917	-135.4107	Calling the top. The beach side is a barrier and then once across road there is a place where flow is running across bedrock and no pools for resting or jumping making a velocity barrier. Electrofished above road also and caught no fish.	EF	no fish
-----	---------	-----------	---	----	---------

Figure 118.—Looking upstream from near mouth 3 ½ Mile Creek.

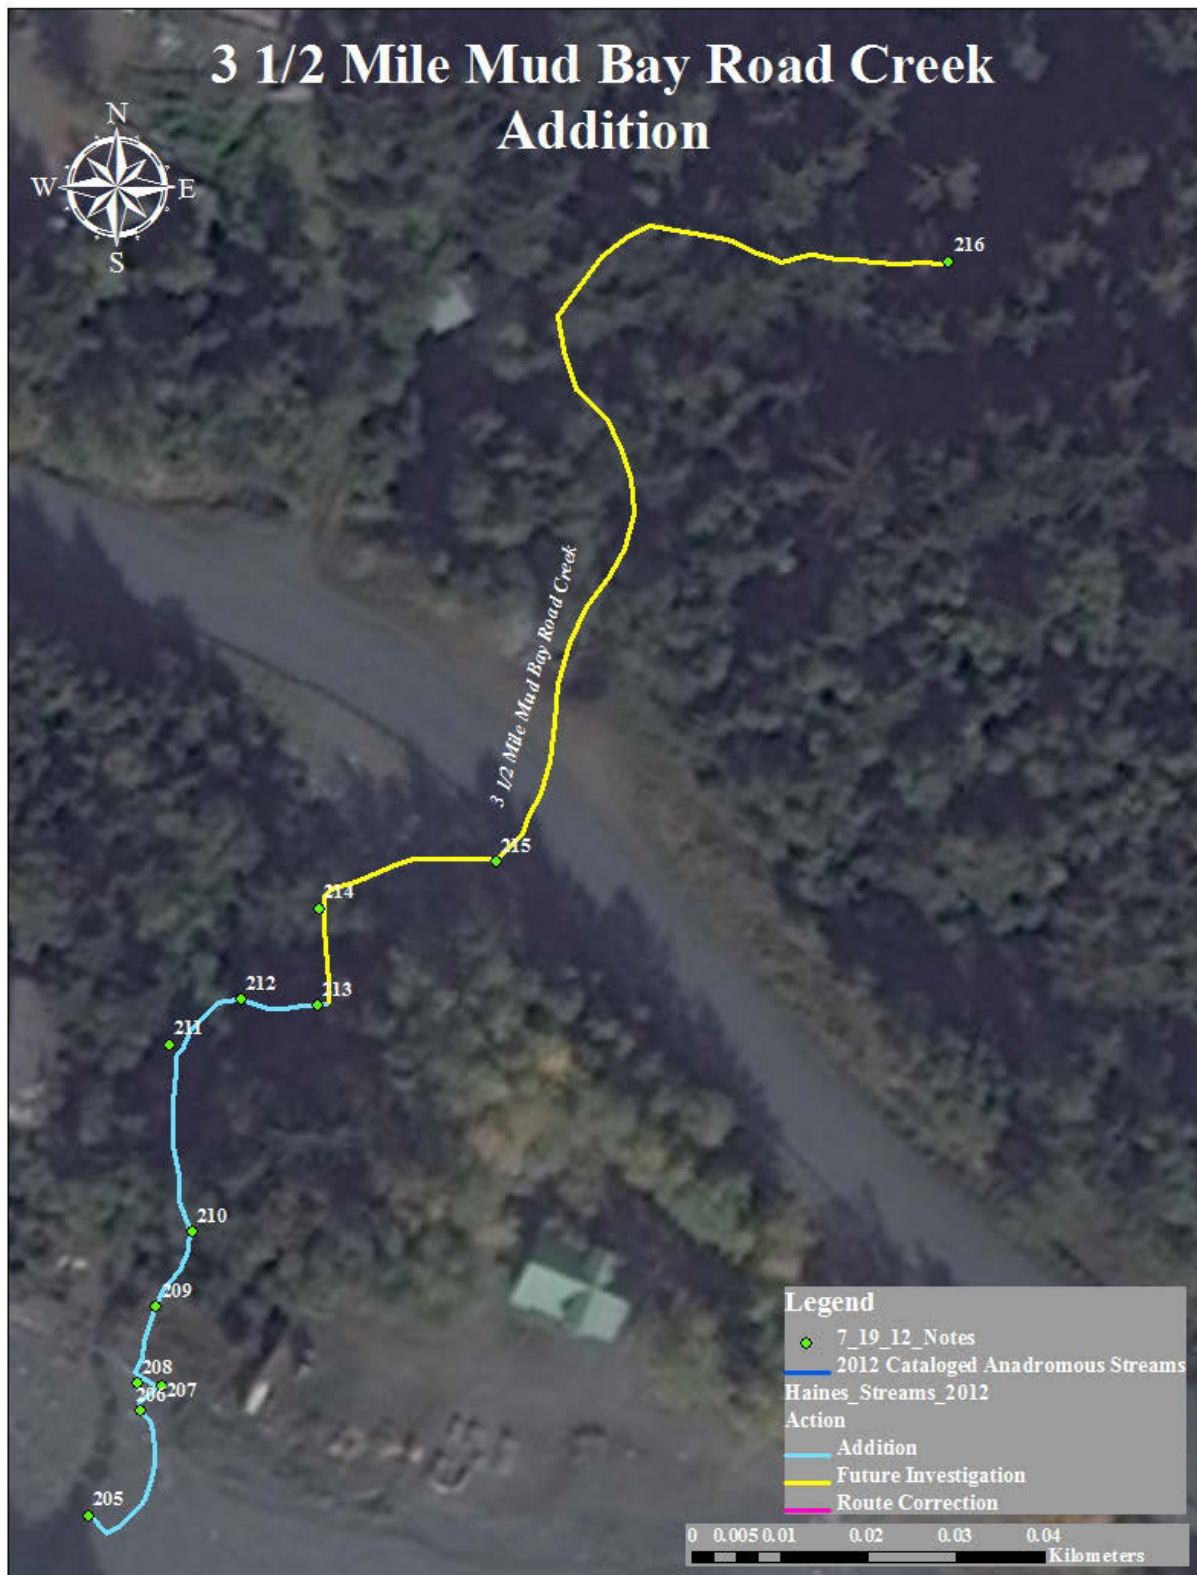
Figure 119.—Map of 3½ Mile Mud Bay Road route correction map.

**Recommendations:** Update this stream's route, upper, and lower limits in the AWC.

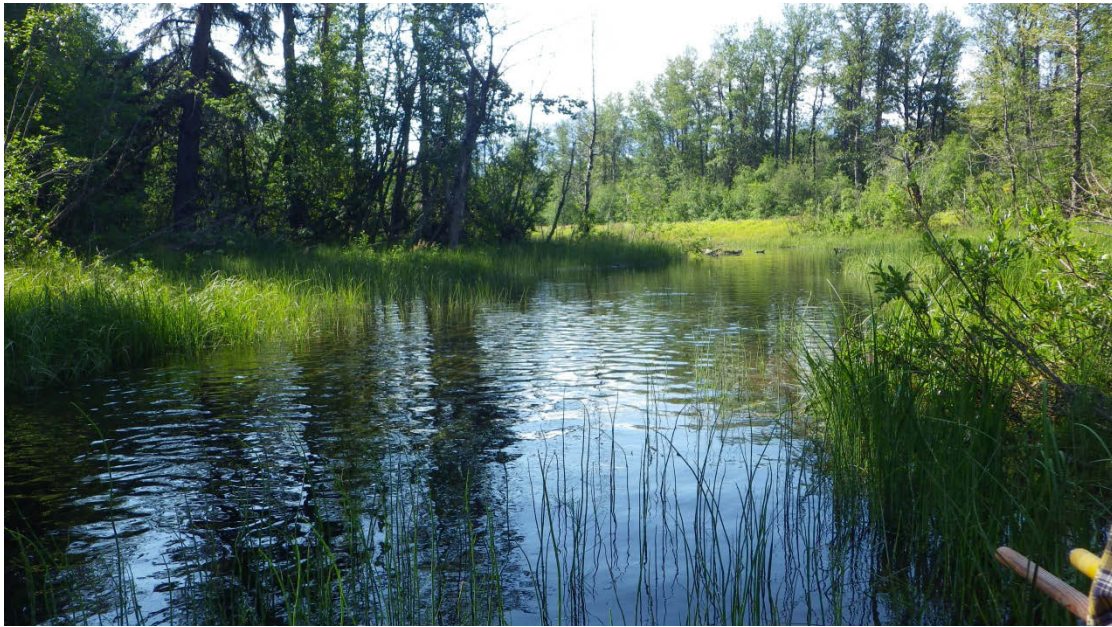
199	59.3310	-135.7447	Calling this the top of 14-Mile Creek. The high velocity water is very channelized with minimal resting pools. Electrofished in calm areas and caught no fish.	EF	no fish
-----	---------	-----------	--	----	---------

Figure 120.—Looking upstream in 14 Mile Creek above Haines Highway culvert.

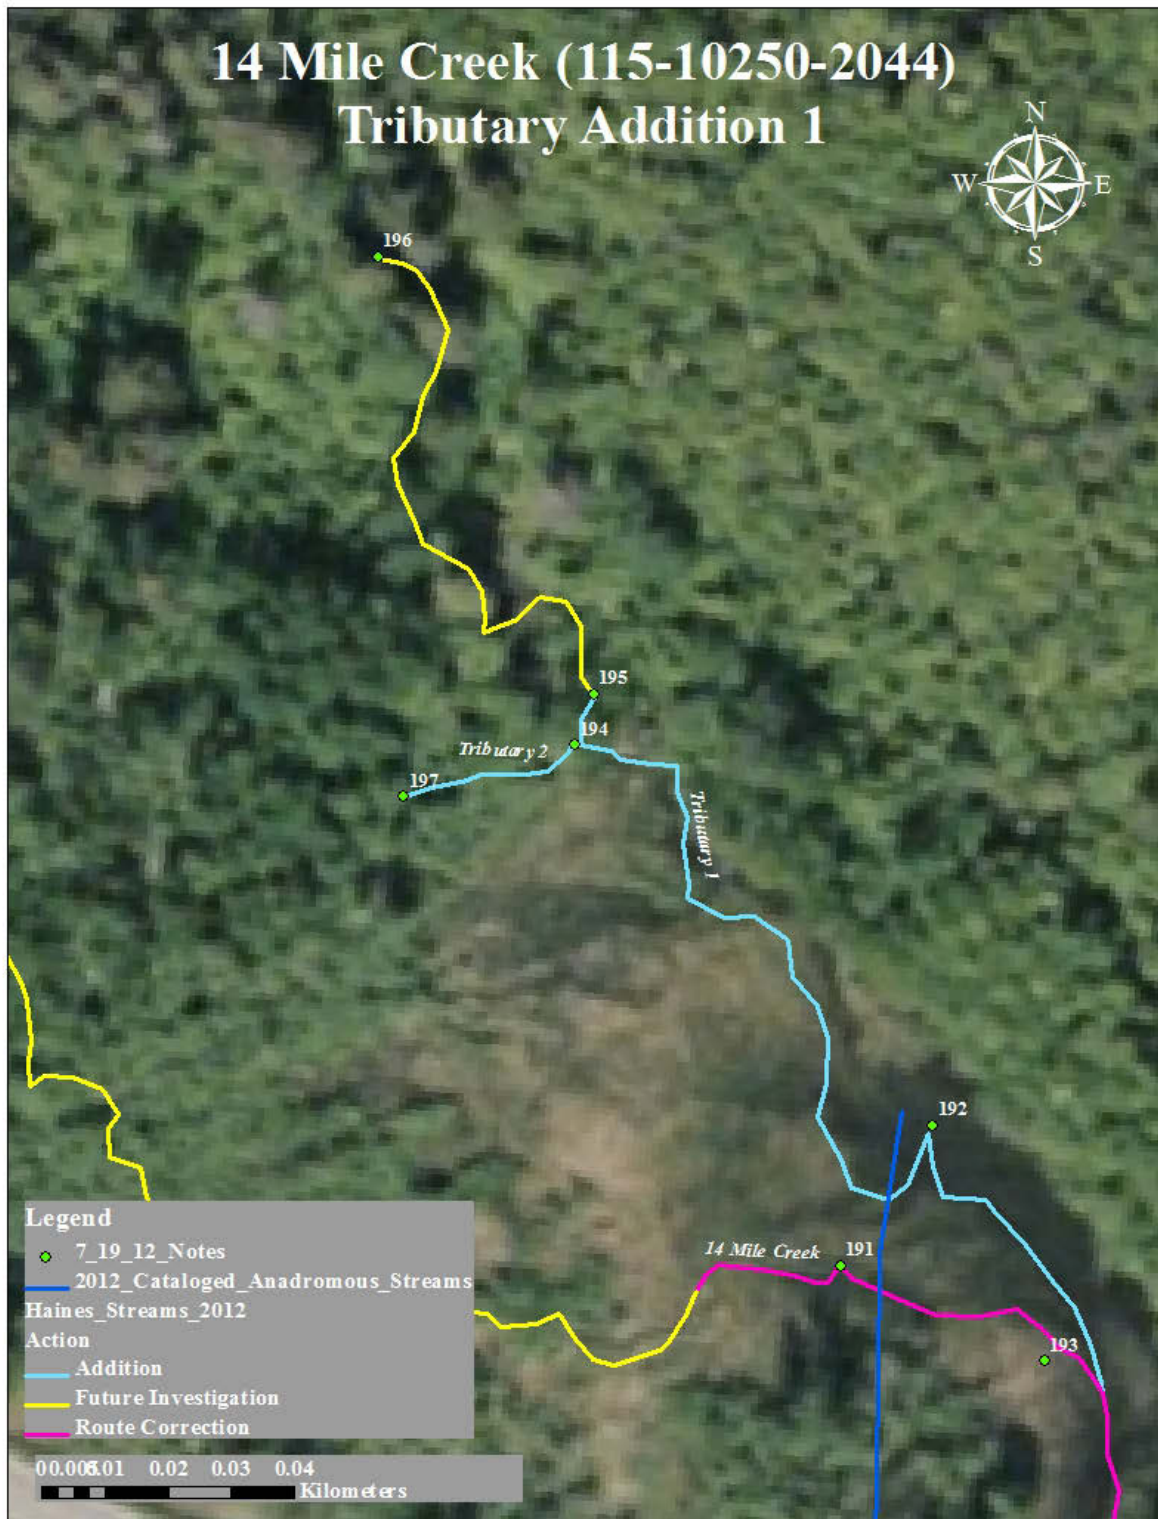
Figure 123.—14 Mile Creek tributary 1 addition map.

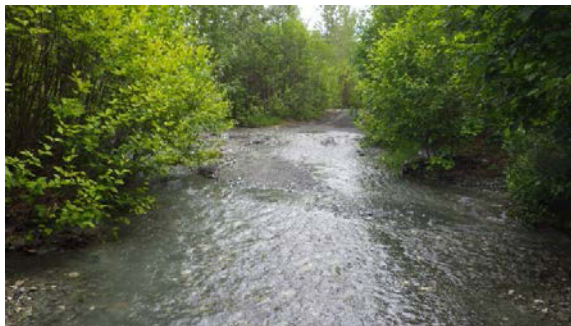
Figure 125.–Looking downstream at 23.1 Mile Creek where it crosses a road (WPT 50).

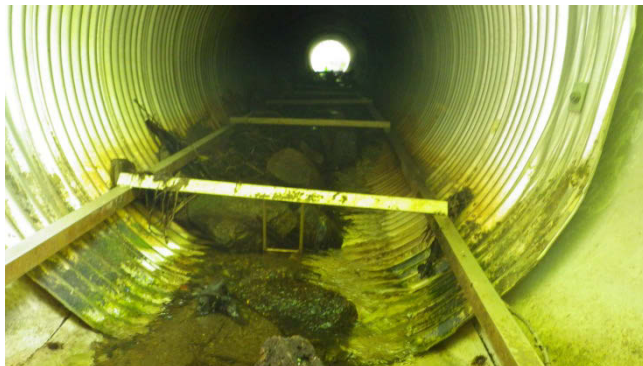
Figure 131.—Culvert beneath Mud Bay Road with fish passage modifications.

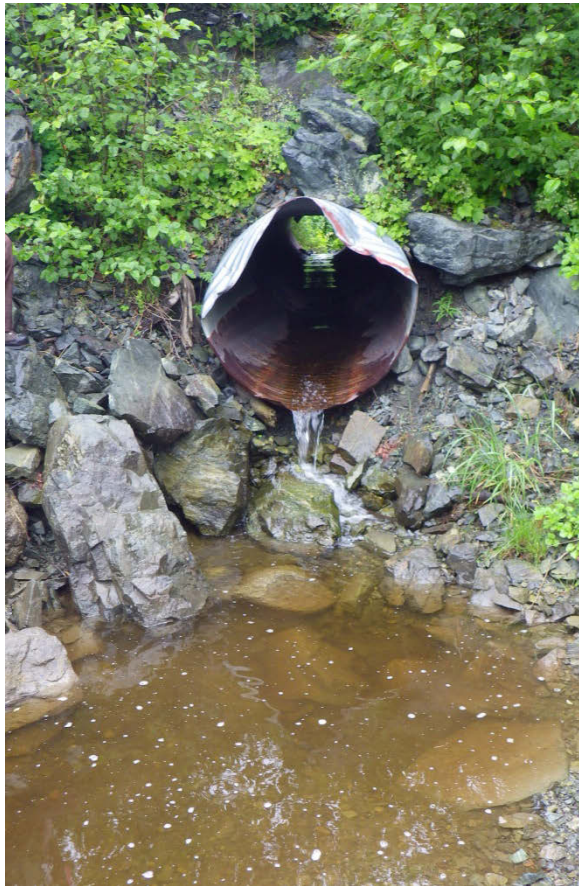
Figure 139.—Perched and damaged culvert near mouth of Cannery Creek (WPT 3).

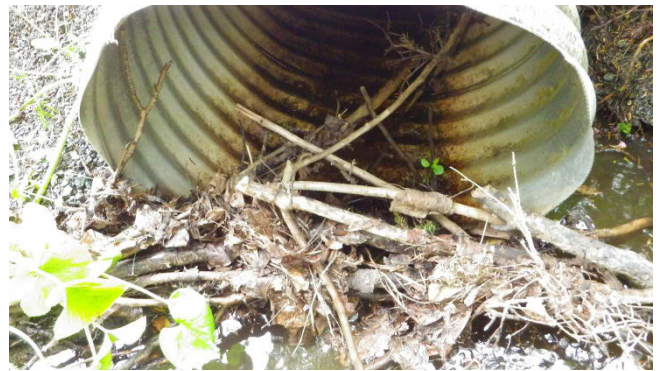
Figure 141.—Culvert filled with debris restricting flow (WPT 7).

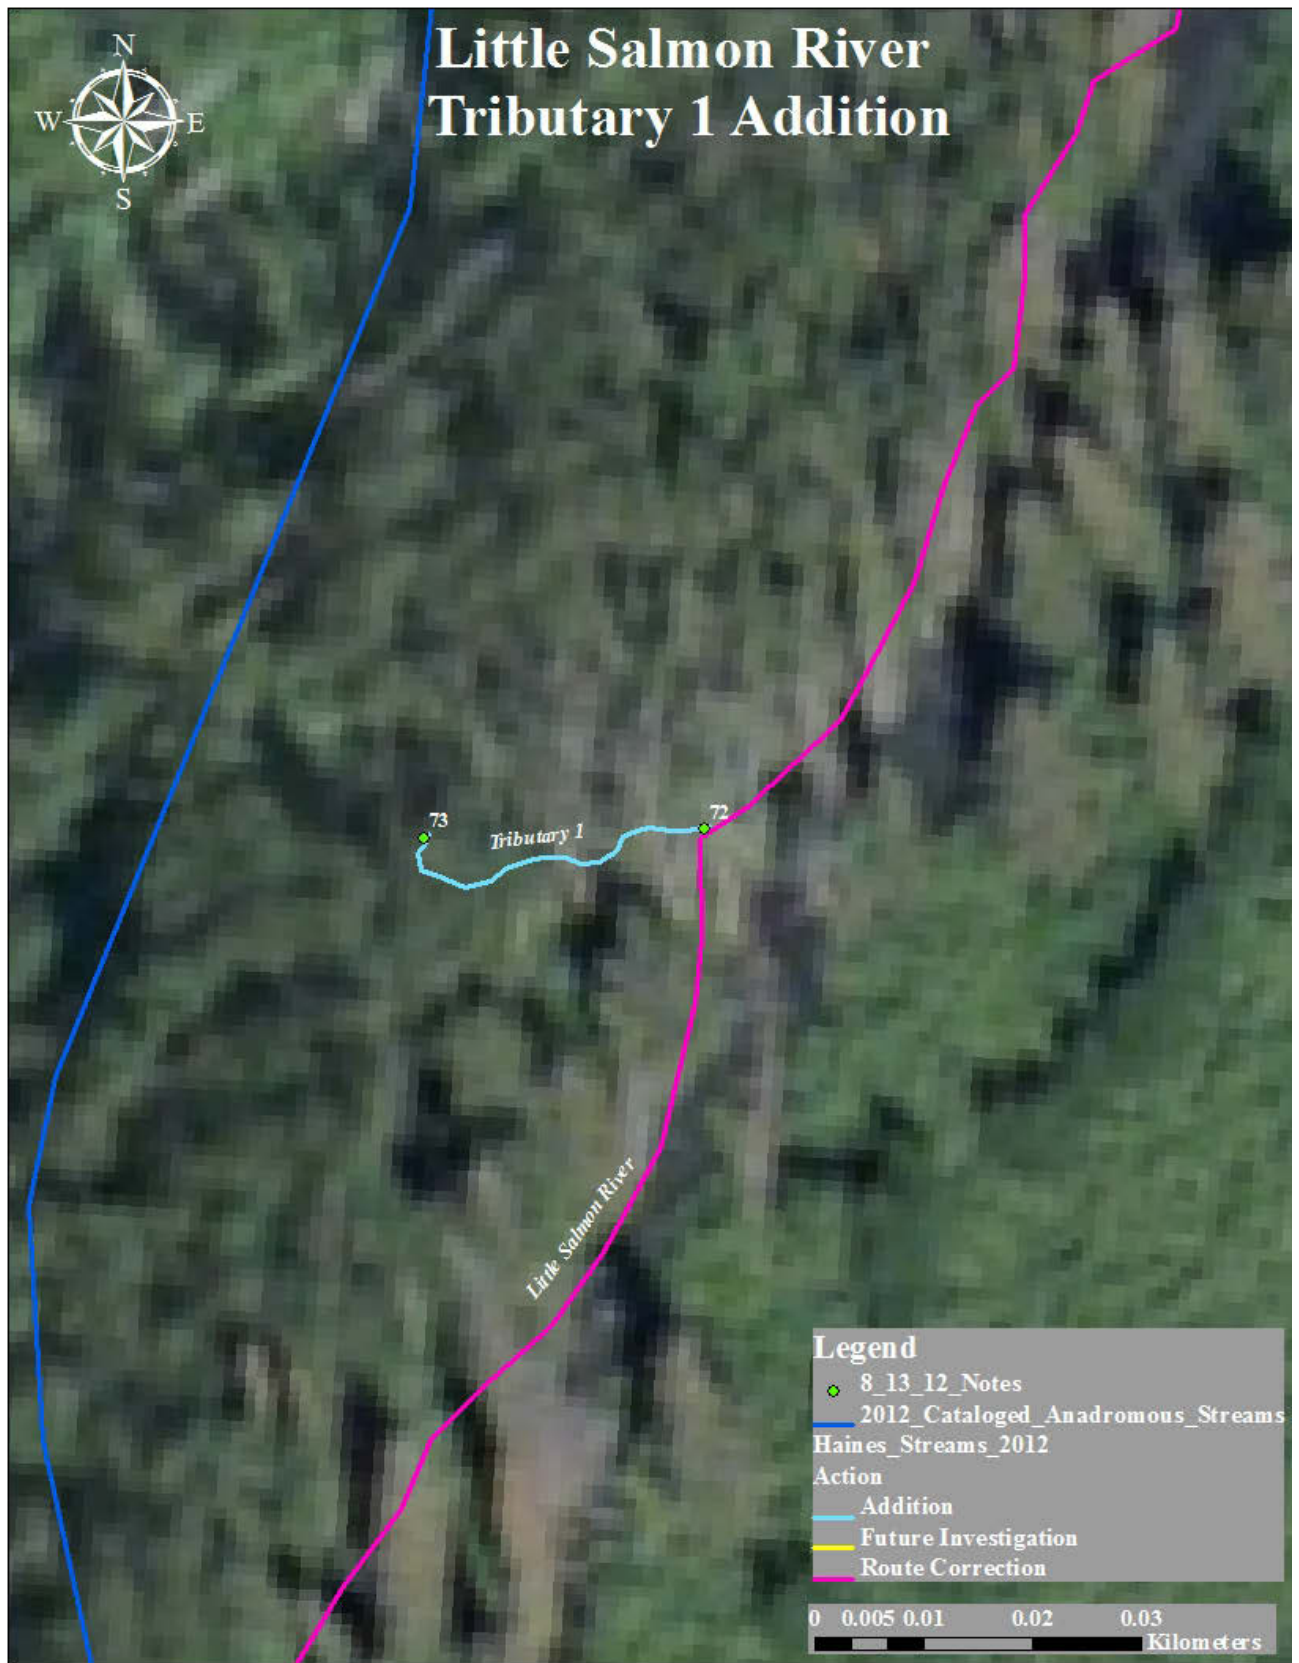
Figure 146.—Little Salmon River tributary 1 addition map.

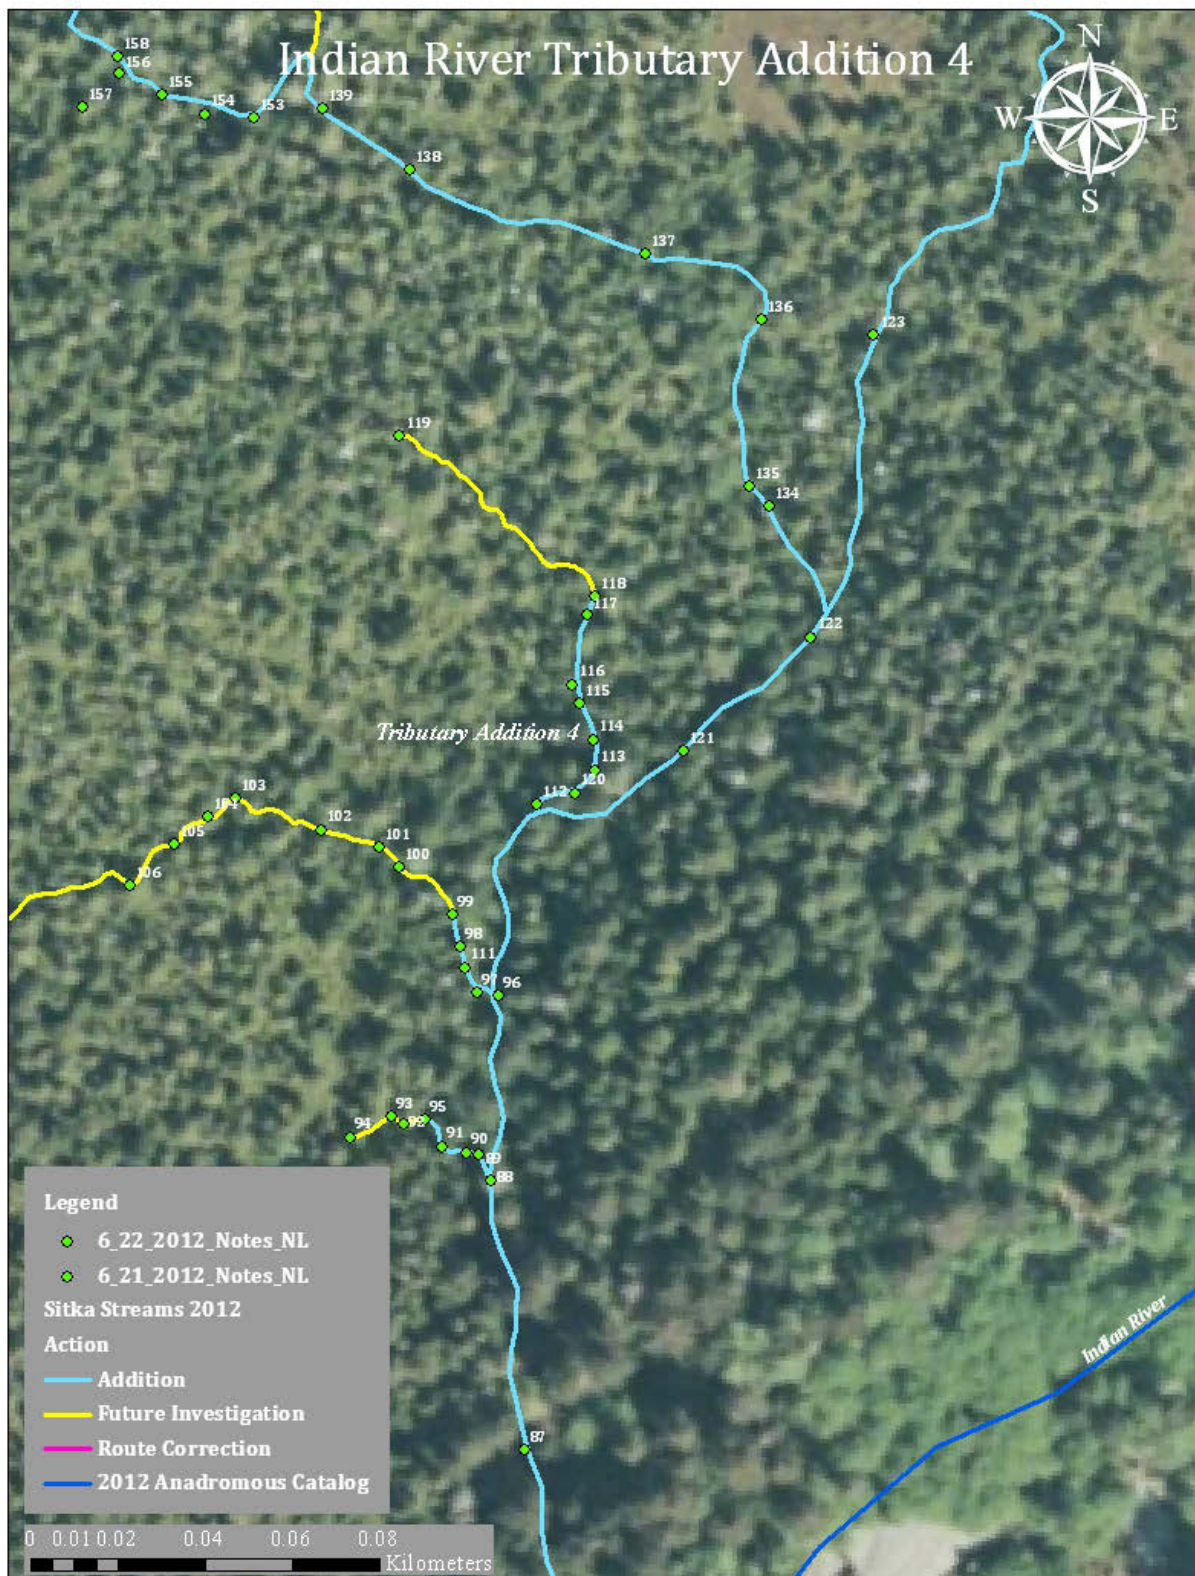
Figure 189.–Indian River Tributary Addition 4 map.

**Recommendations:** We recommend adding this stream course to the Anadromous Waters Catalog. This anadromous section extends from WPT 112 to WPT 118.

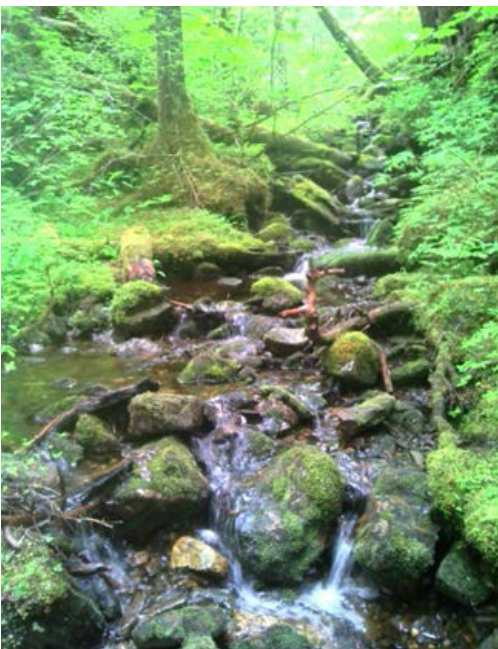
**Findings:** This stream provides good habitat near its confluence with the main Indian River Tributary 1, then quickly picks up gradient and becomes a narrow incised channel. We caught many Dolly Varden char above the steep section where it flattens out again, but no coho were found.

Figure 190.—Indian River tributary 5 gradient increase.

**Recommendations:** We recommend adding this stream course to the Anadromous Waters Catalog. The anadromous portion extends from WPT 96 to WPT 99.
