**Technical Report No. 13-04**

# **Documenting Anadromous Water Bodies Southeast Alaska**

Alaska Department of Fish and Game

Division of Habitat

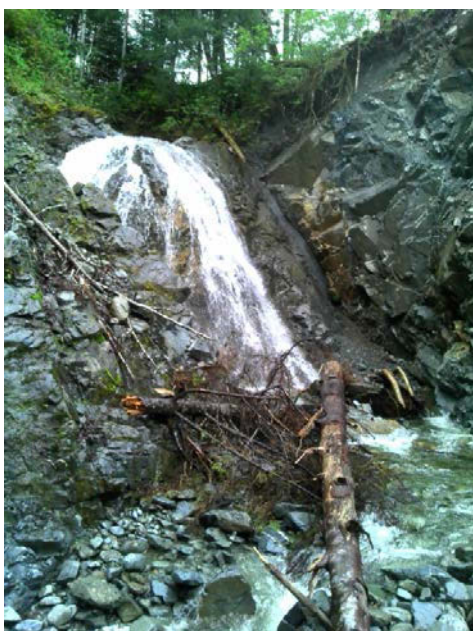
Figure 205.–Granite Creek tributary 1 waterfall barrier.

**Recommendations:** We recommend adding this stream course in the Anadromous Waters Catalog.

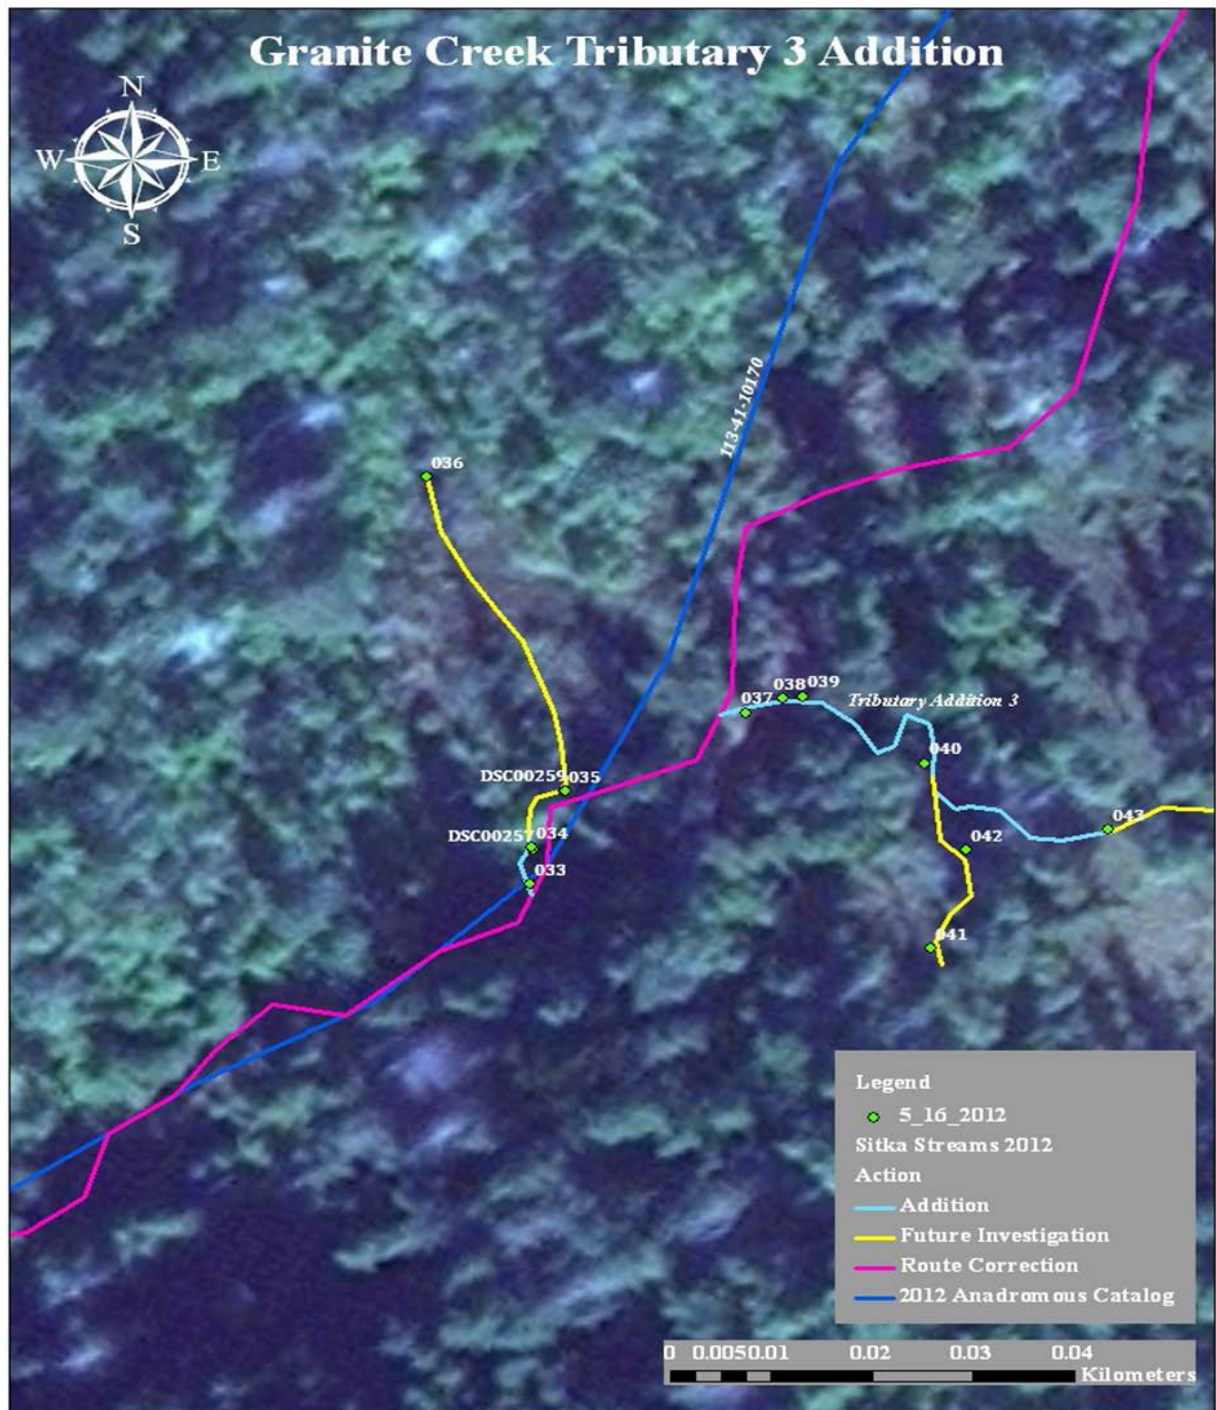
Figure 210.—Granite Creek tributary addition 3 map.

**Recommendations:** We recommend adding this stream course in the Anadromous Waters Catalog.

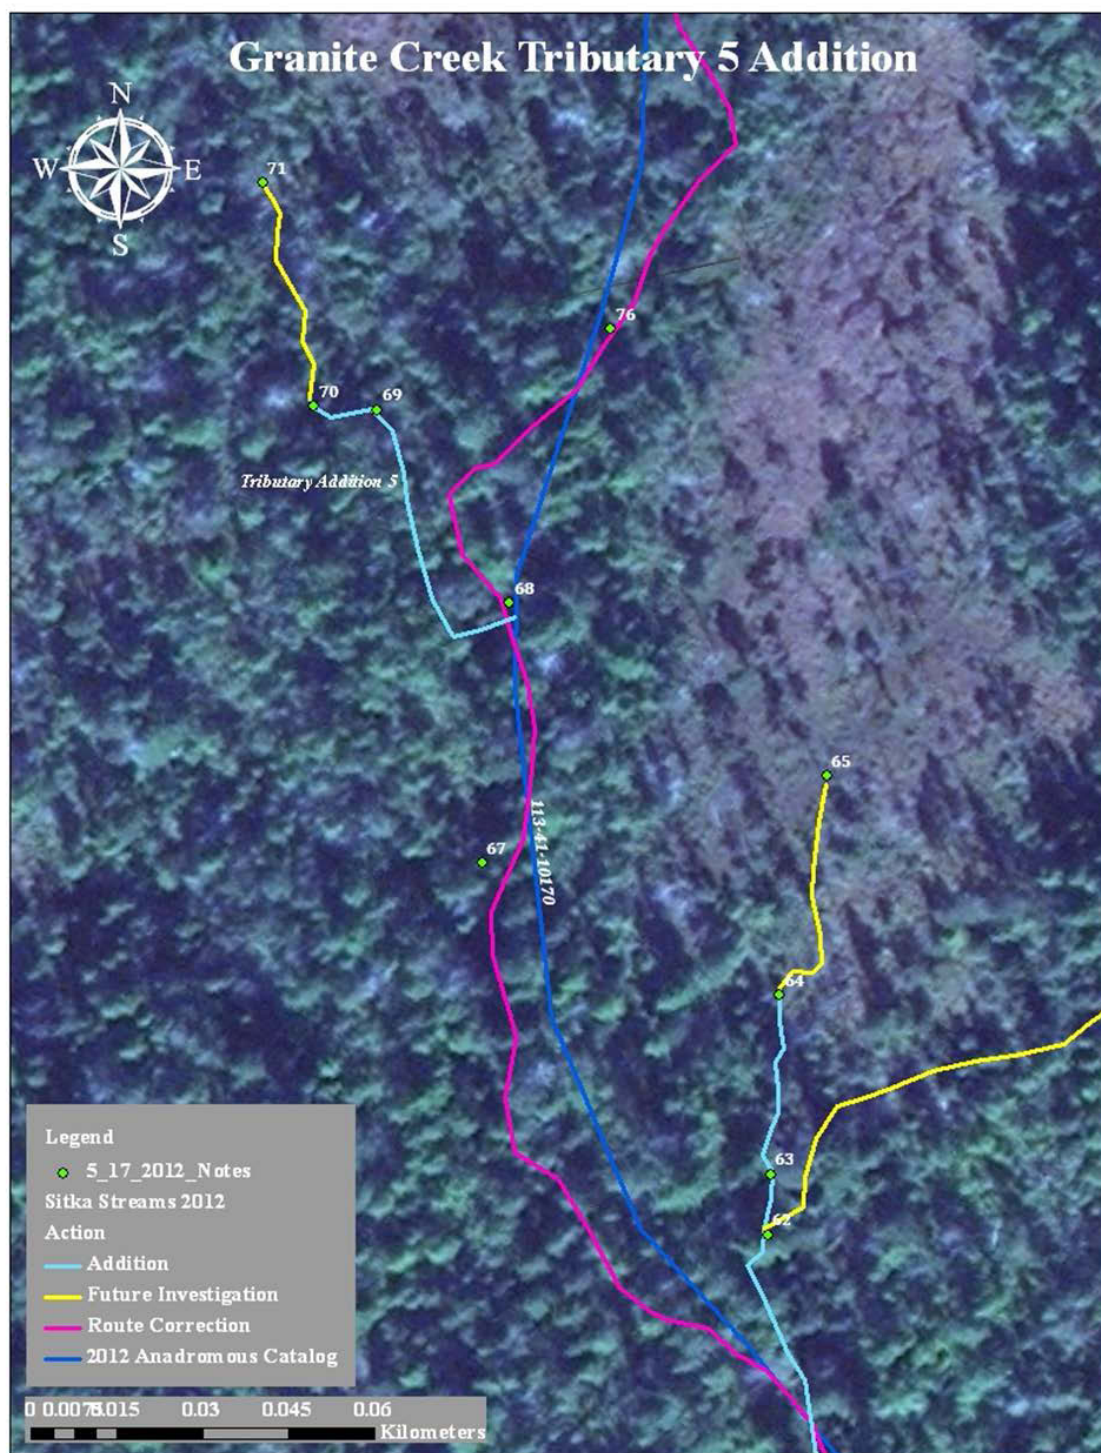
Figure 214.—Granite Creek tributary addition 5 map.

**Recommendations:** We recommend adding this stream course in the Anadromous Waters Catalog.
