# Appendix N: Prince of Wales Island

## Guide to direct fieldwork for cataloging anadromous water bodies in Southeast Alaska

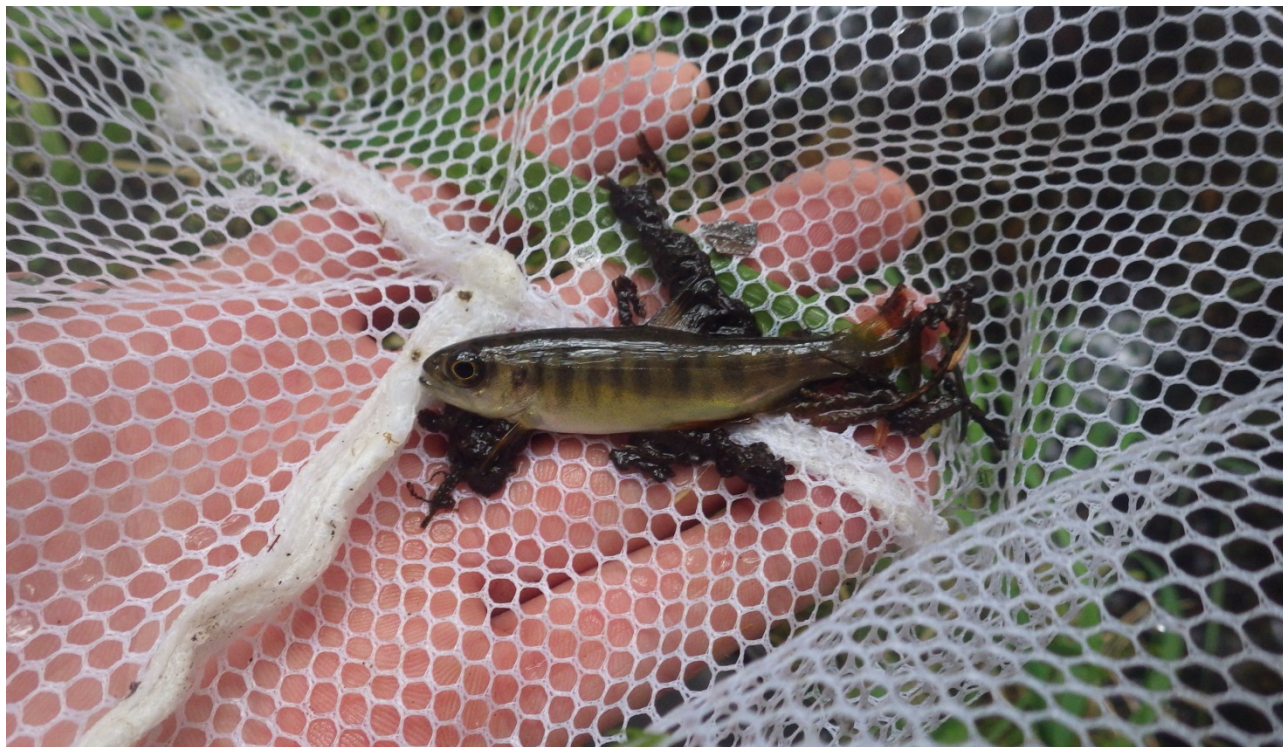
Figure 1.—Coho captured at Waypoint 666.

**Findings:** We surveyed this stream and found coho salmon (Table 1; Figure 1). The stream originates from several underground seeps.

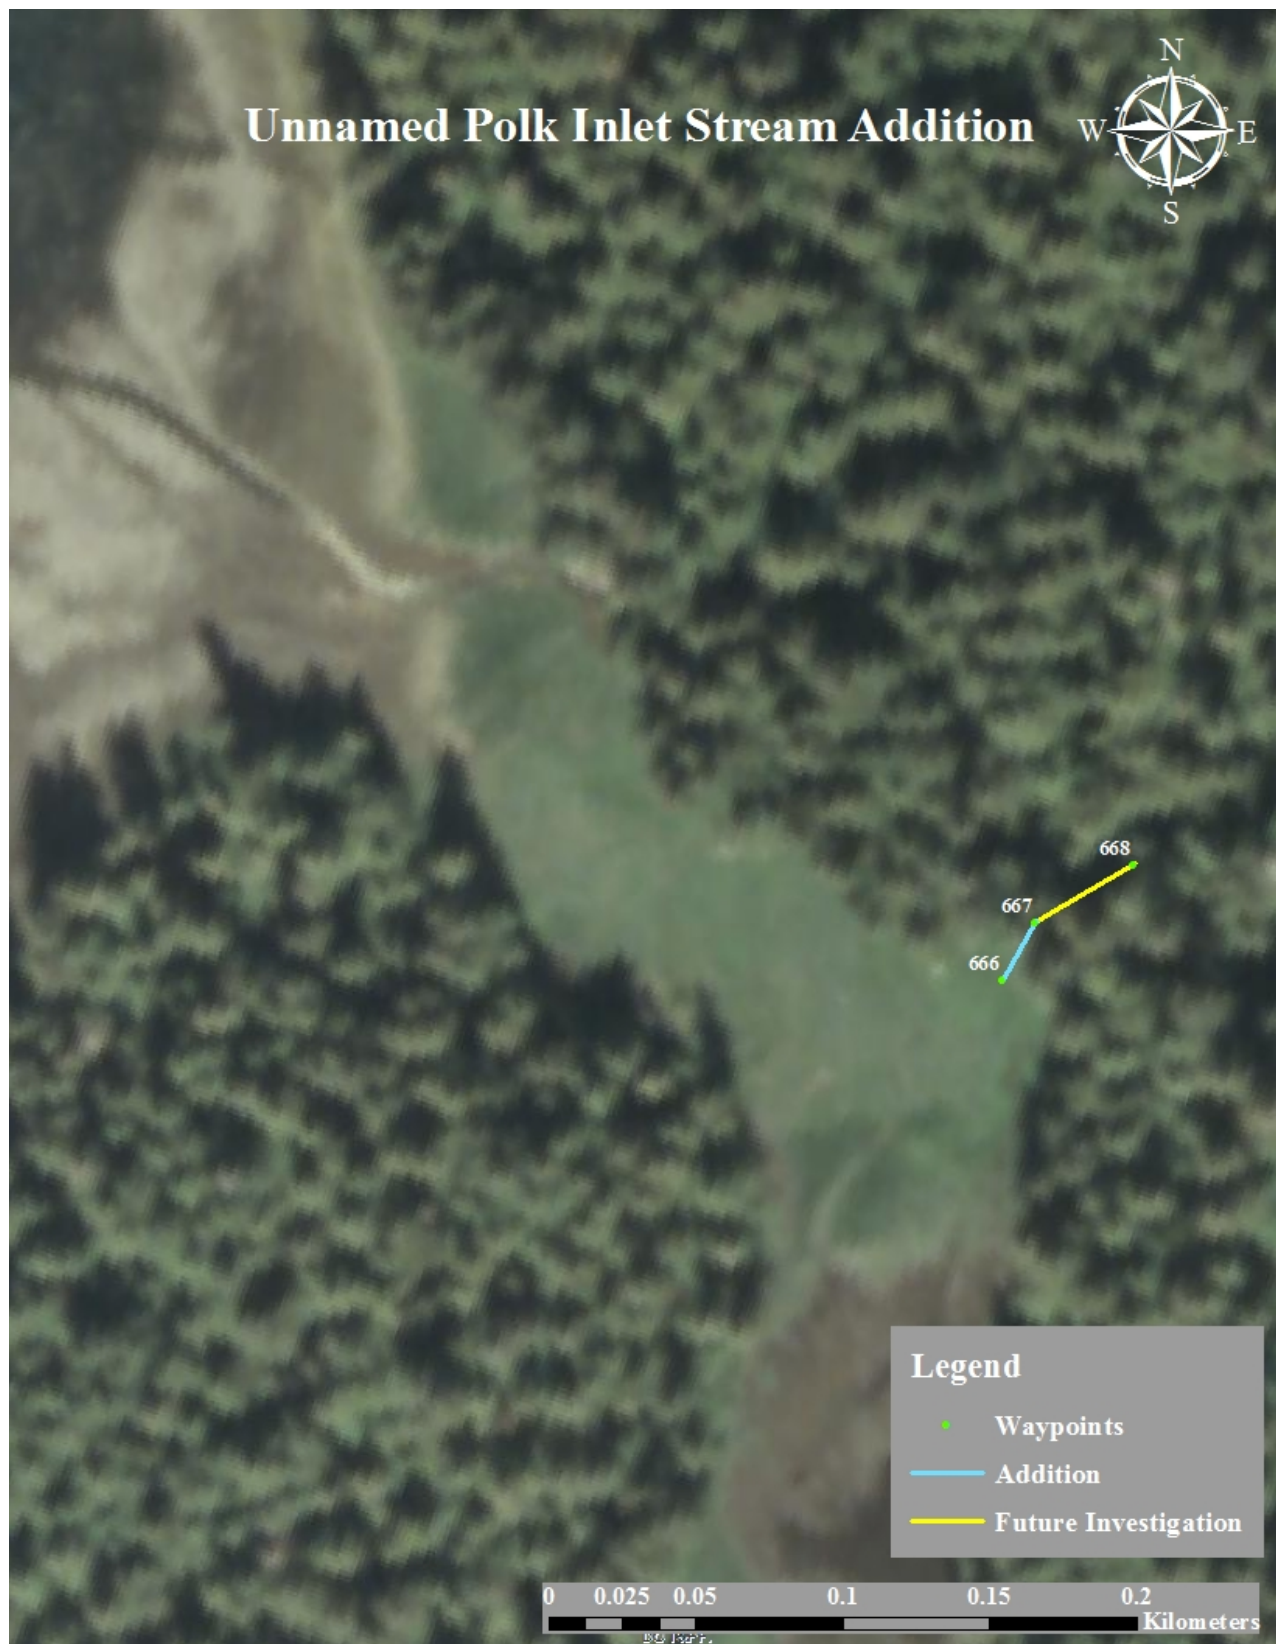
Figure 2.-102-60-10335 (Unnamed Polk Inlet stream) addition map.

**Recommendations:** Add the segment of the stream between waypoints 666 and 667 to the Anadromous Waters Catalog, and investigate the upper reaches of the stream at a later date (Figure 2).

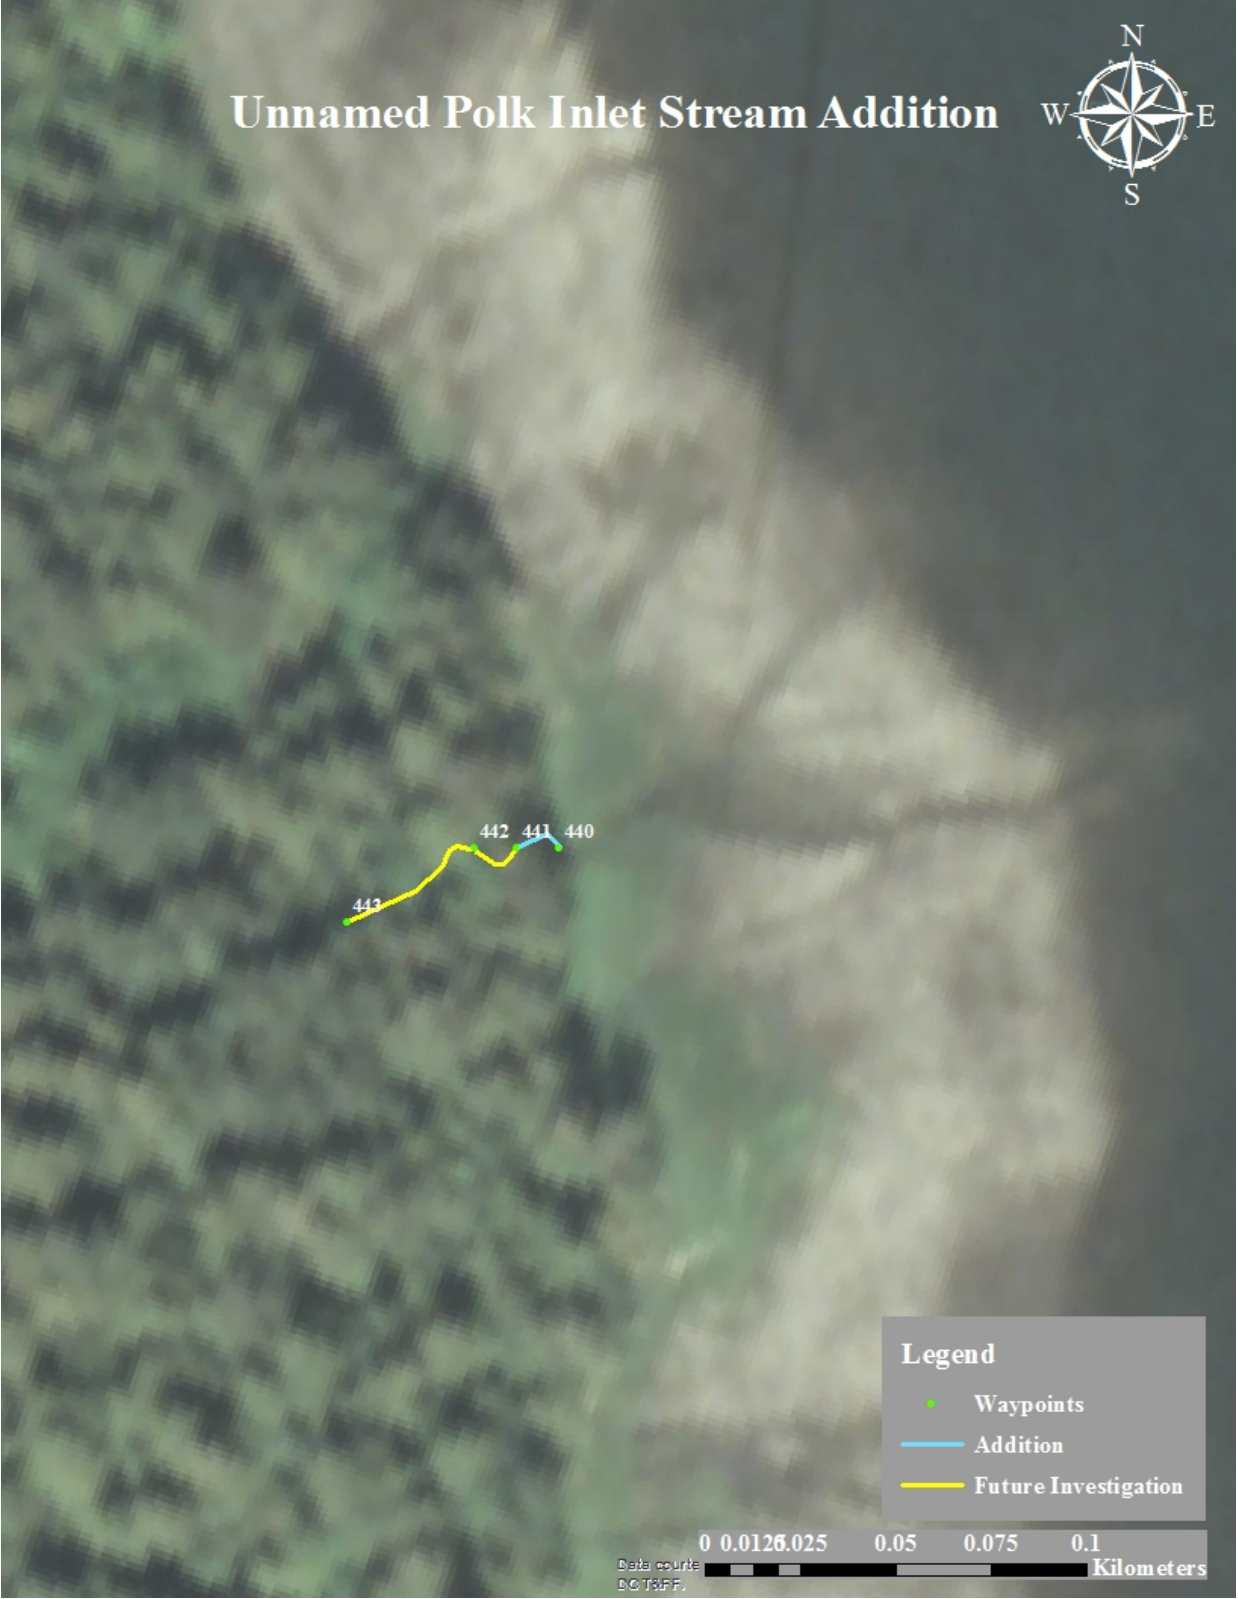
Figure 4.-102-60-10374 (Unnamed Polk Inlet stream) addition map.

**Recommendations:** Add the indicated portion of the stream to the Anadromous Waters Catalog and investigate the upper portion at a later date (Figure 4).

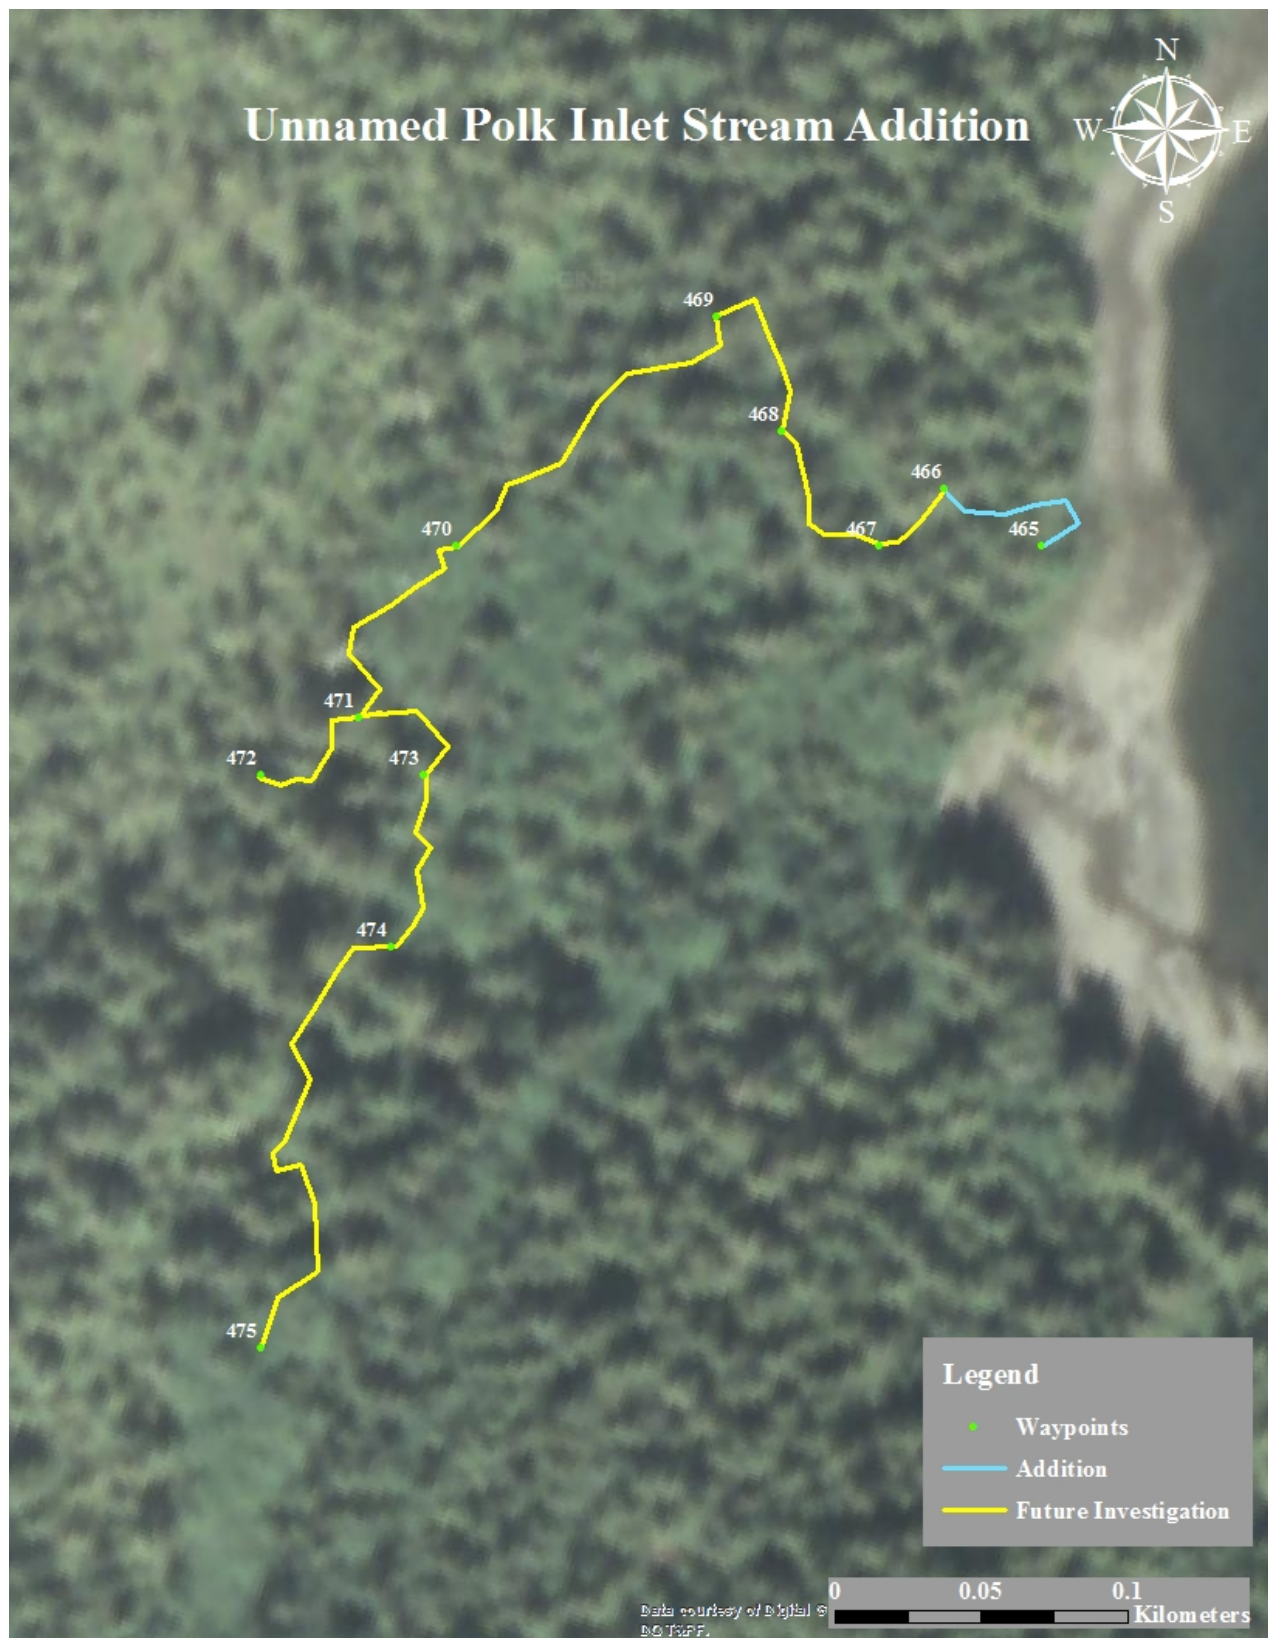
Figure 2.-102-60-10377 (Unnamed Polk Inlet stream) addition map.

**Recommendations:** Add the section of this stream between waypoints 465 and 466 to the Anadromous Waters Catalog and investigate the upper reaches at a later date (Figure 2).

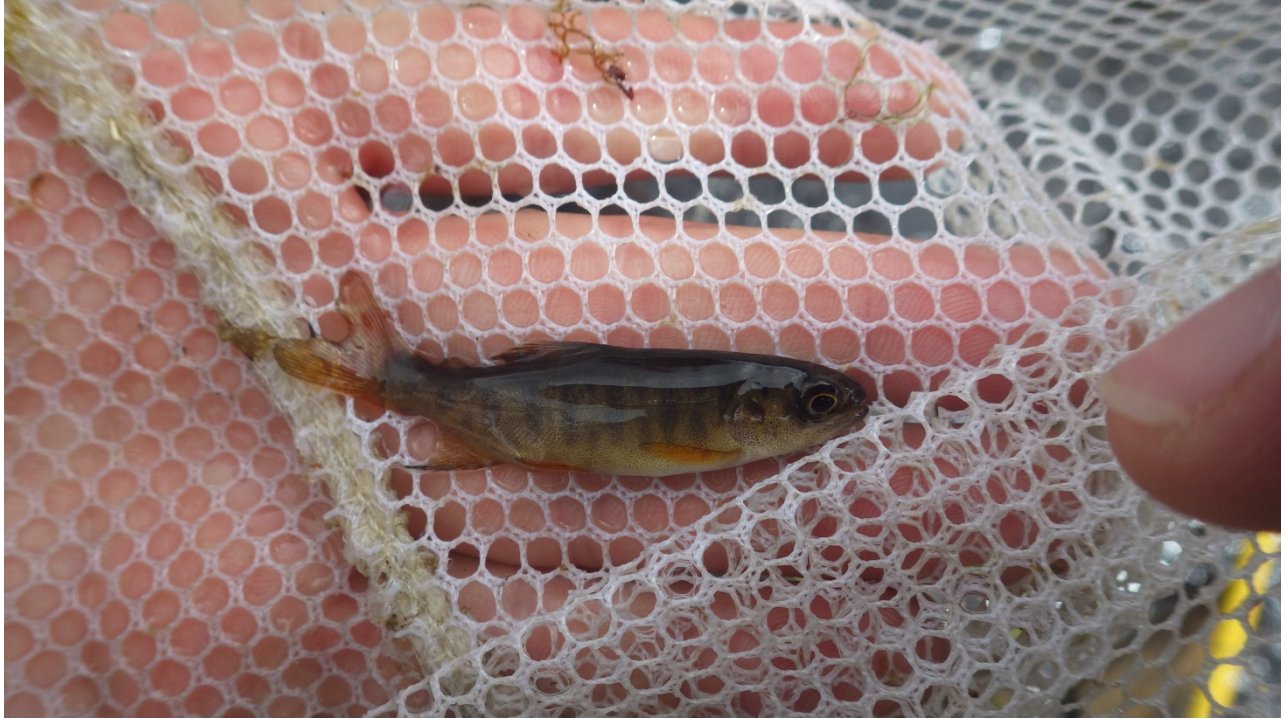
Figure 1.—Juvenile coho salmon captured at waypoint 328.

**Findings:** We surveyed this stream using an electrofisher and a GPS and found juvenile coho salmon (Table 1; Figure 1). The stream crosses a meadow (Figure 2) and we found several beaver dams and ponds.

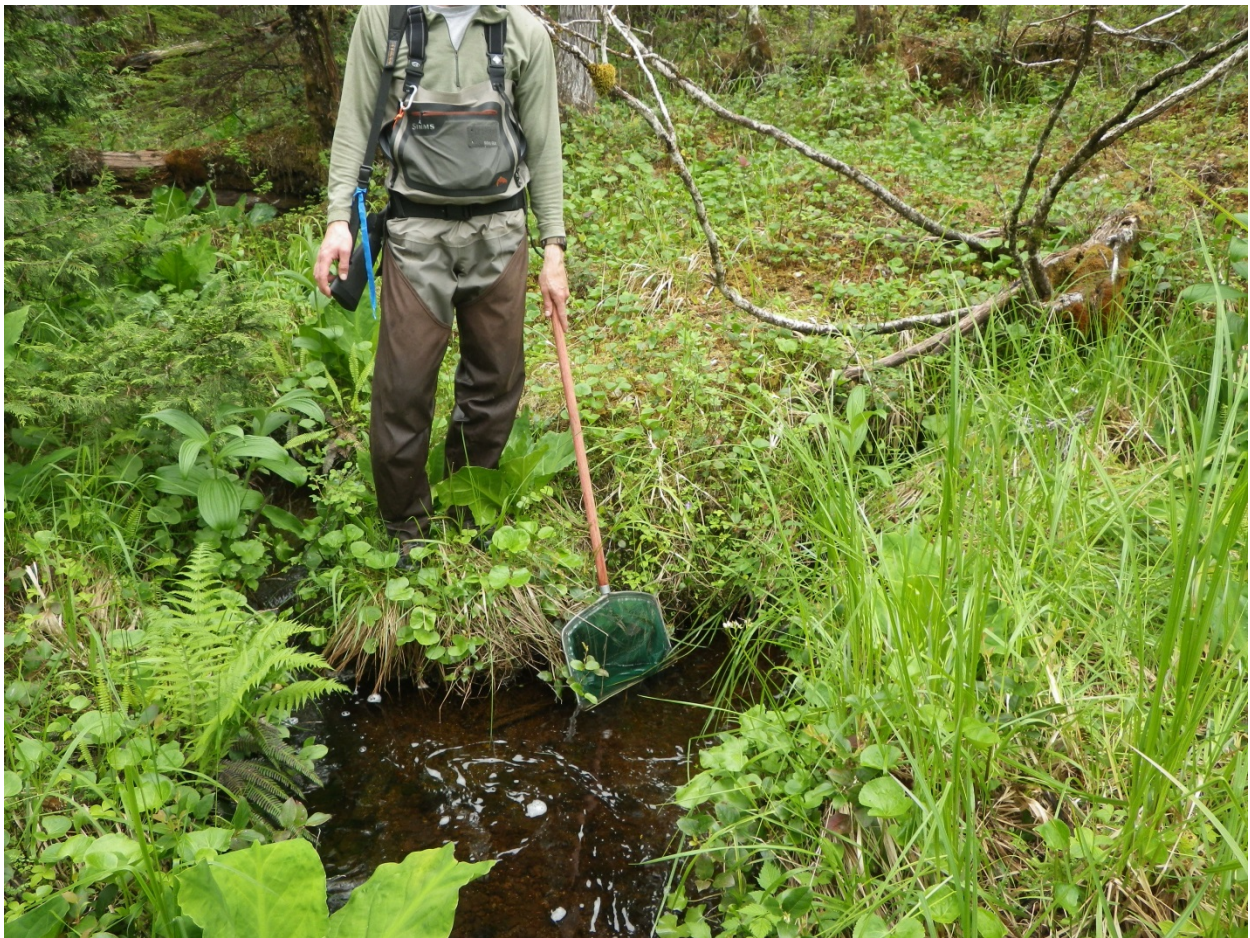
**Findings:** We surveyed this stream using an electrofisher and GPS and found coho salmon and cutthroat trout (Table 1; Figure 1). We ended the survey where the stream forked into two 1 ft. wide branches of increasingly steep grade (Figure 2).

Figure 2.—Stream splits into 2 narrow forks before gradient increases at waypoint 49.

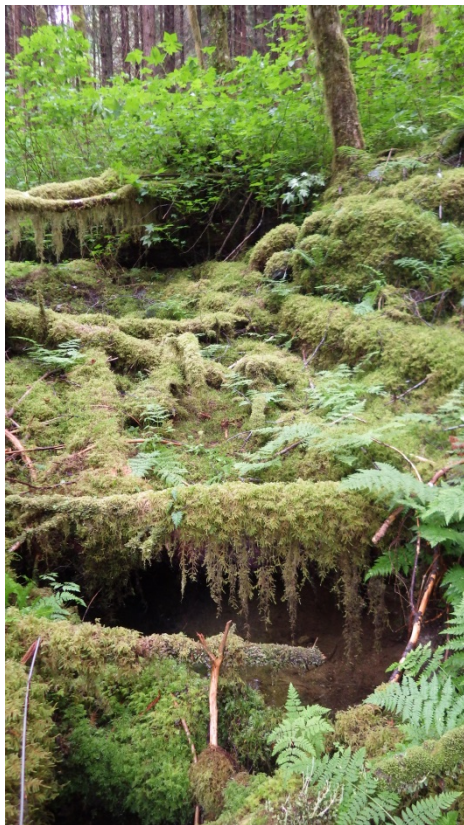
Figure 1.–Tributary emerges from bed of old logging road at waypoint 120.

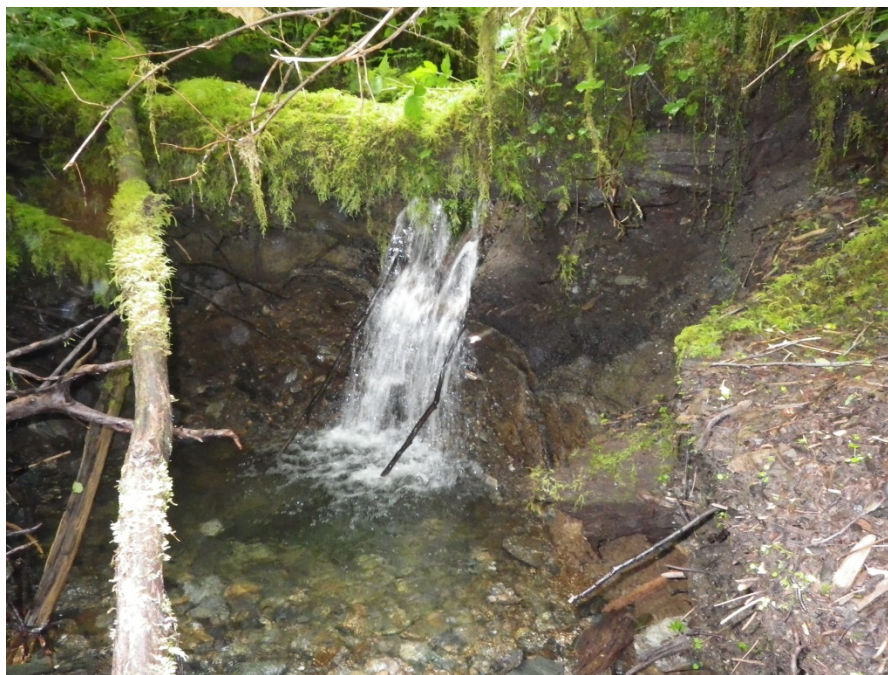
Waypoint	Latitude	Longitude	Notes	Sample Effort	Sample Results
121	55.3164	-132.6953	New trib. Barrier at this point, 4 ft tall and fairly incised into loose talus. Proceeding down trib.		
122	55.3164	-132.6949	No fish.		
123	55.3165	-132.6944	Channel runs dry at low water flows.		
124	55.3166	-132.6944	25 CO observed.	EF/VI	25 CO
125	55.3166	-132.6942	Two CO observed, one DV as well.	EF/VI	2 CO, 1 DV
126	55.3167	-132.6940		EF	2 CO
127	55.3168	-132.6935	Confluence of trib with main channel, end survey and proceeding up main channel.

Figure 1.—Fish passage barrier at waypoint 121.

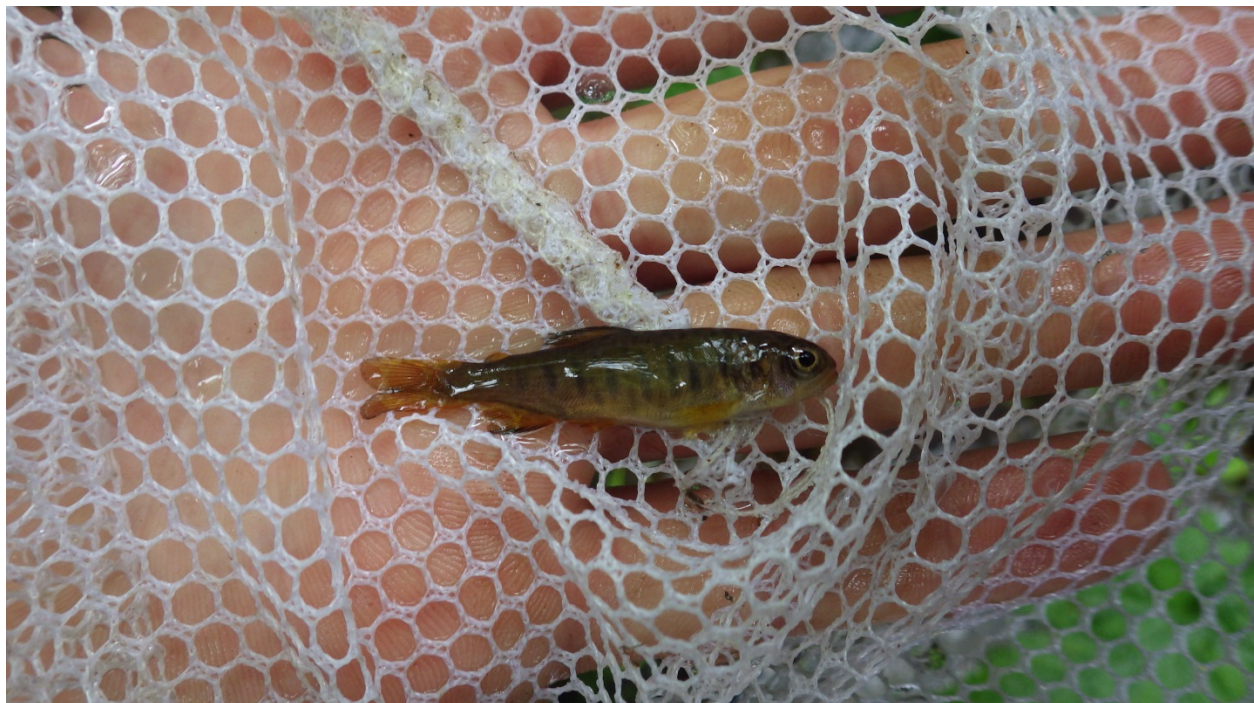
Figure 1.—Juvenile coho salmon captured at waypoint 129.

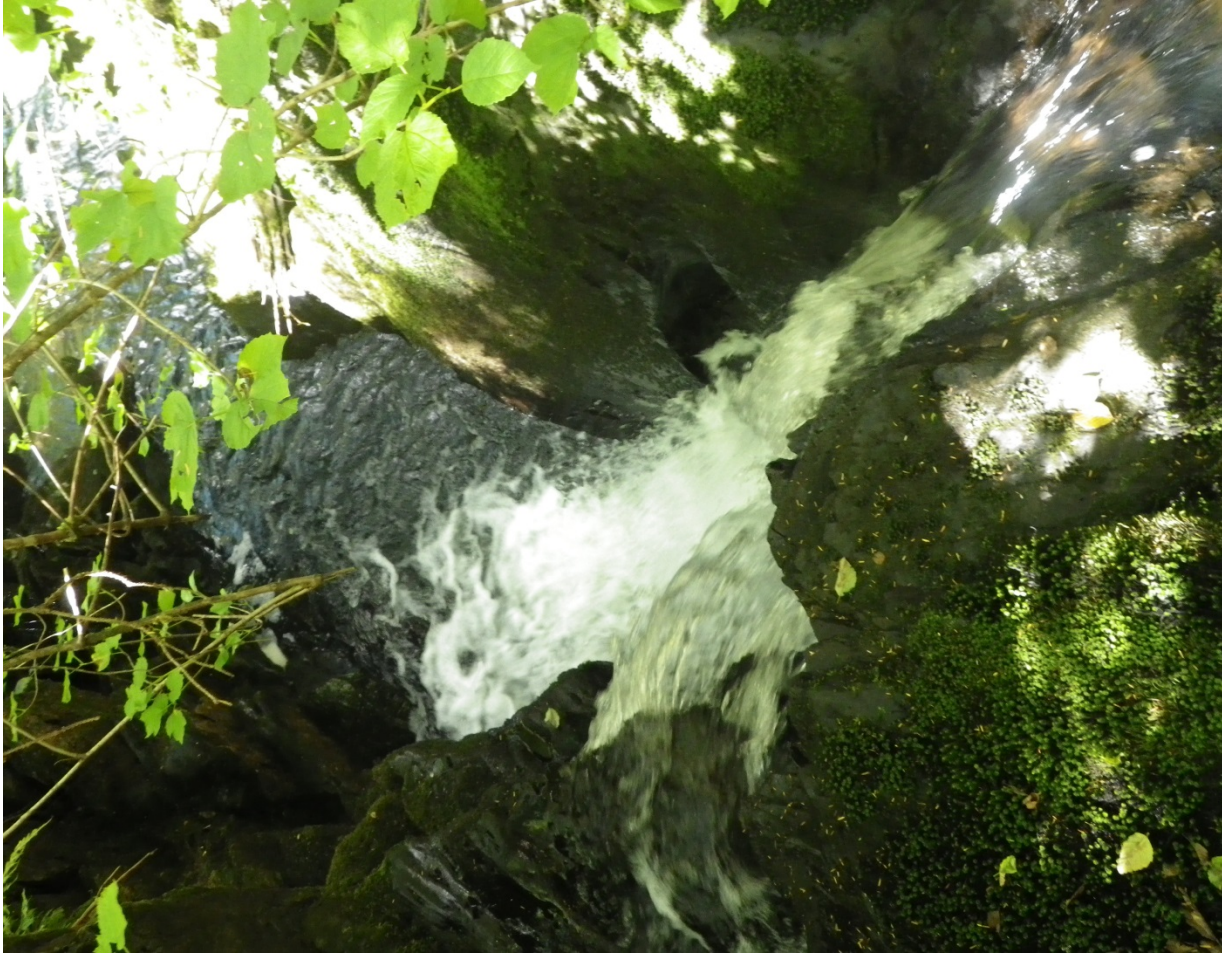
32	55.3425	-132.7942	Top of barrier falls within incised canyon, 8 ft. wide.	EF	No fish
761	55.3426	-132.7949	9 ft. barrier falls, absolute fish barrier. Bottom of falls has a 4 ft. deep jump pool. Falls and pool are very incised. Mostly composed of bedrock.	EF	No fish

Figure 1.–Barrier falls at waypoint 761.

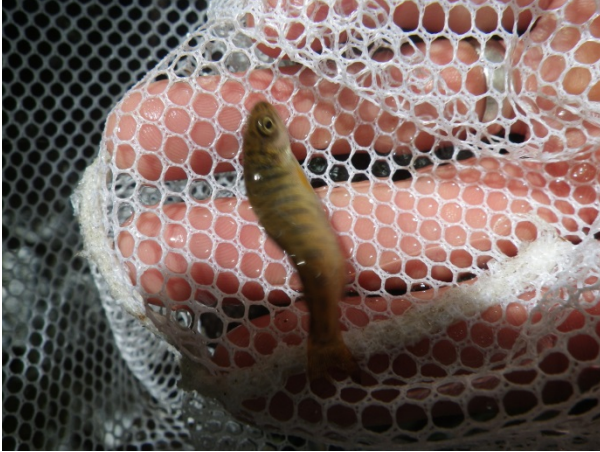
**Findings:** We surveyed this stream and found coho salmon and Dolly Varden char (Table 1; Figure 1). We discovered two large falls, the latter of which is a fish barrier (Figures 2, 3). We captured a Dolly Varden above this falls.

Figure 1.—Coho captured at waypoint 7.

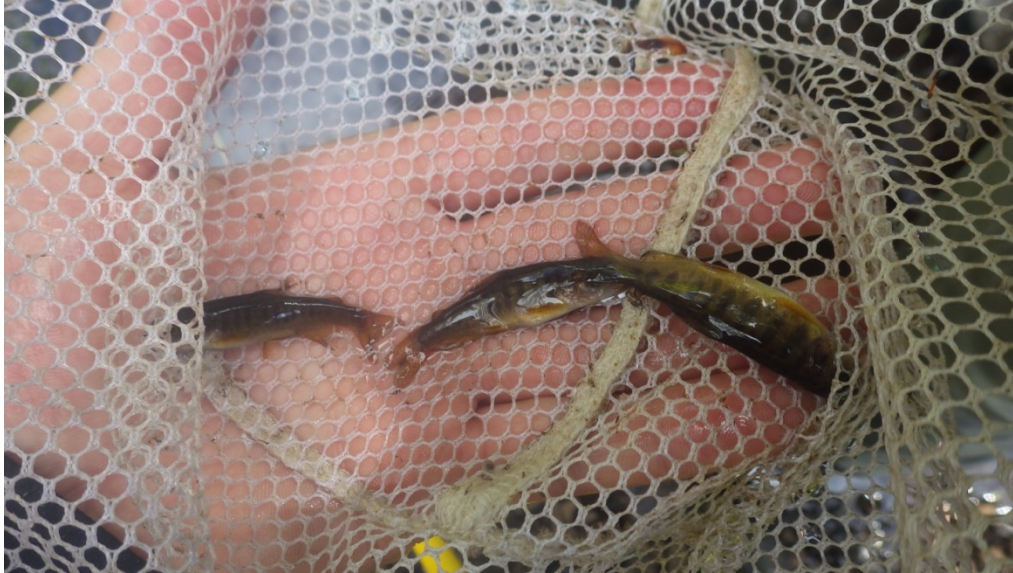
Figure 1.—Three CO captured at WPT 431.

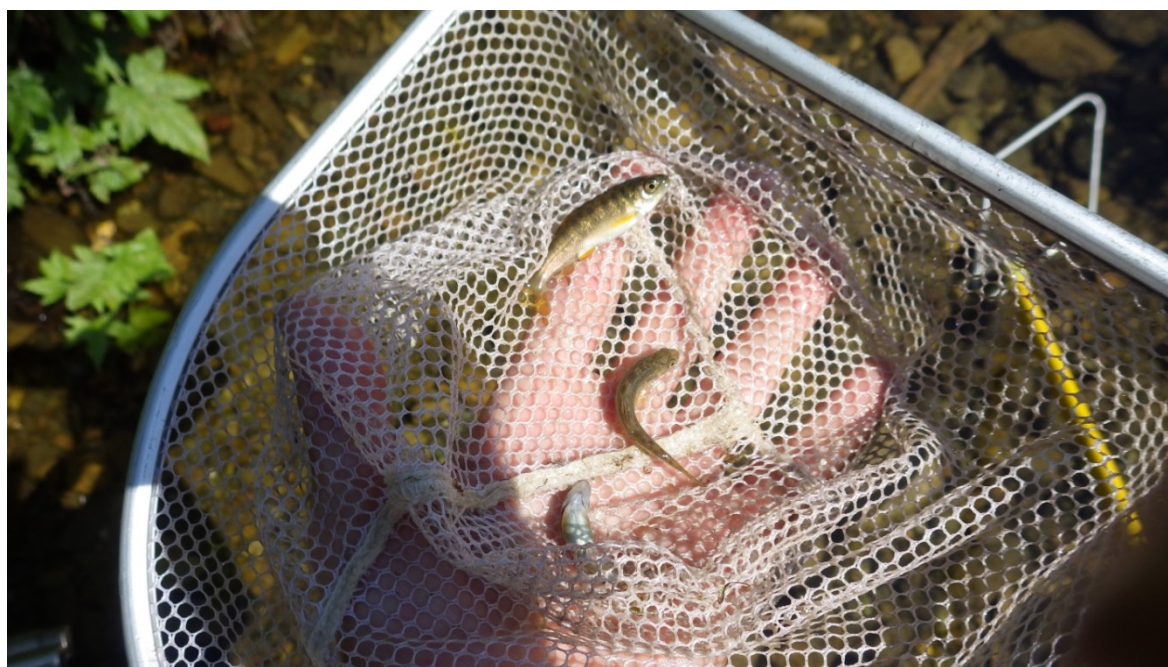
Figure 1.–Coho salmon and Dolly Varden char caught with electrofisher and hand net.

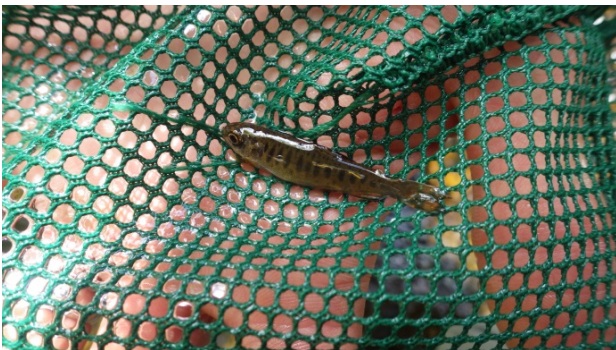
Figure 1.–Coho salmon captured in Turn Creek.

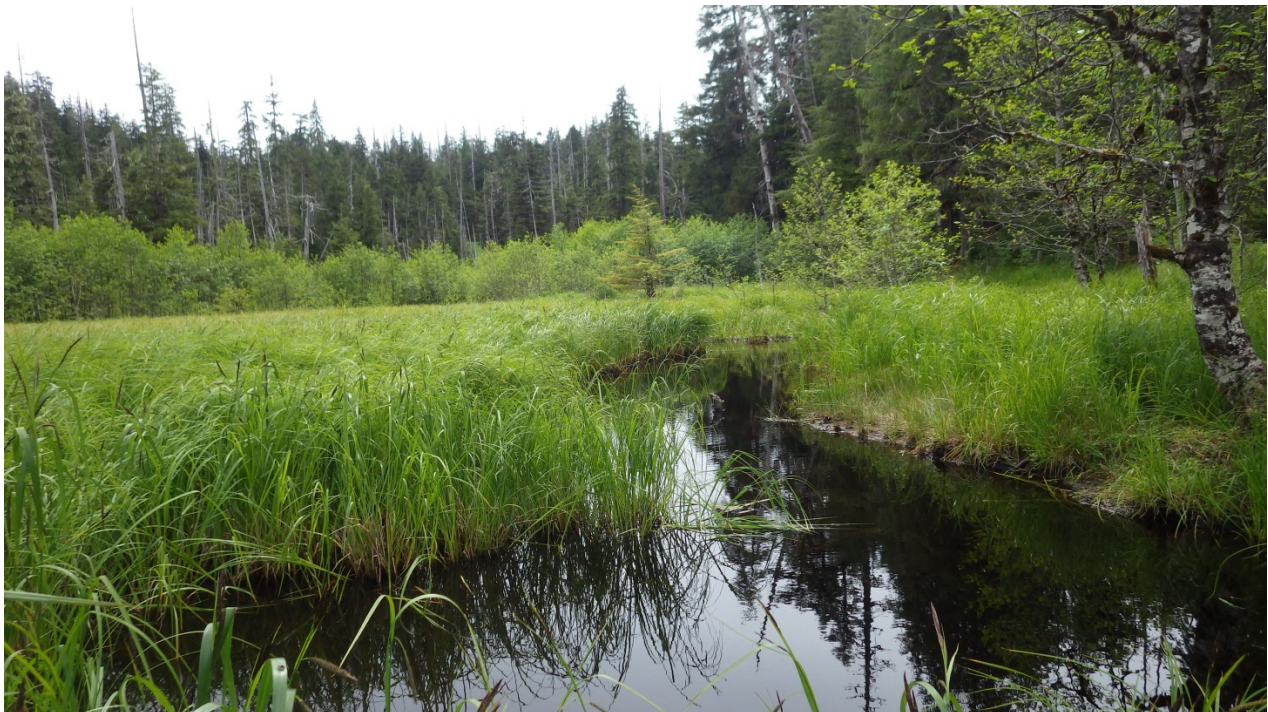
Figure 1.–Beaver ponds/slough near WPT 191.

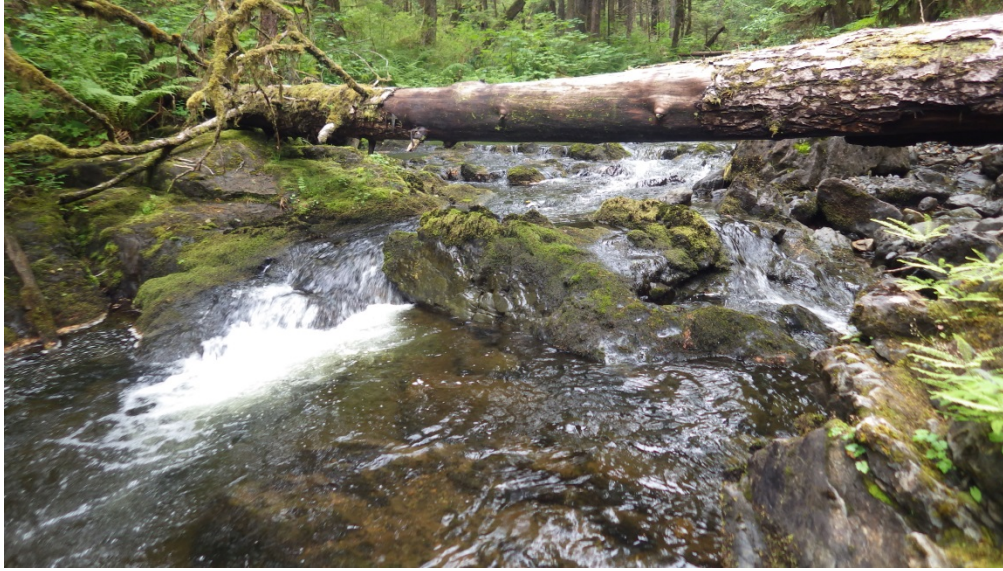
Figure 1.–Small bedrock rapids at waypoint 574.

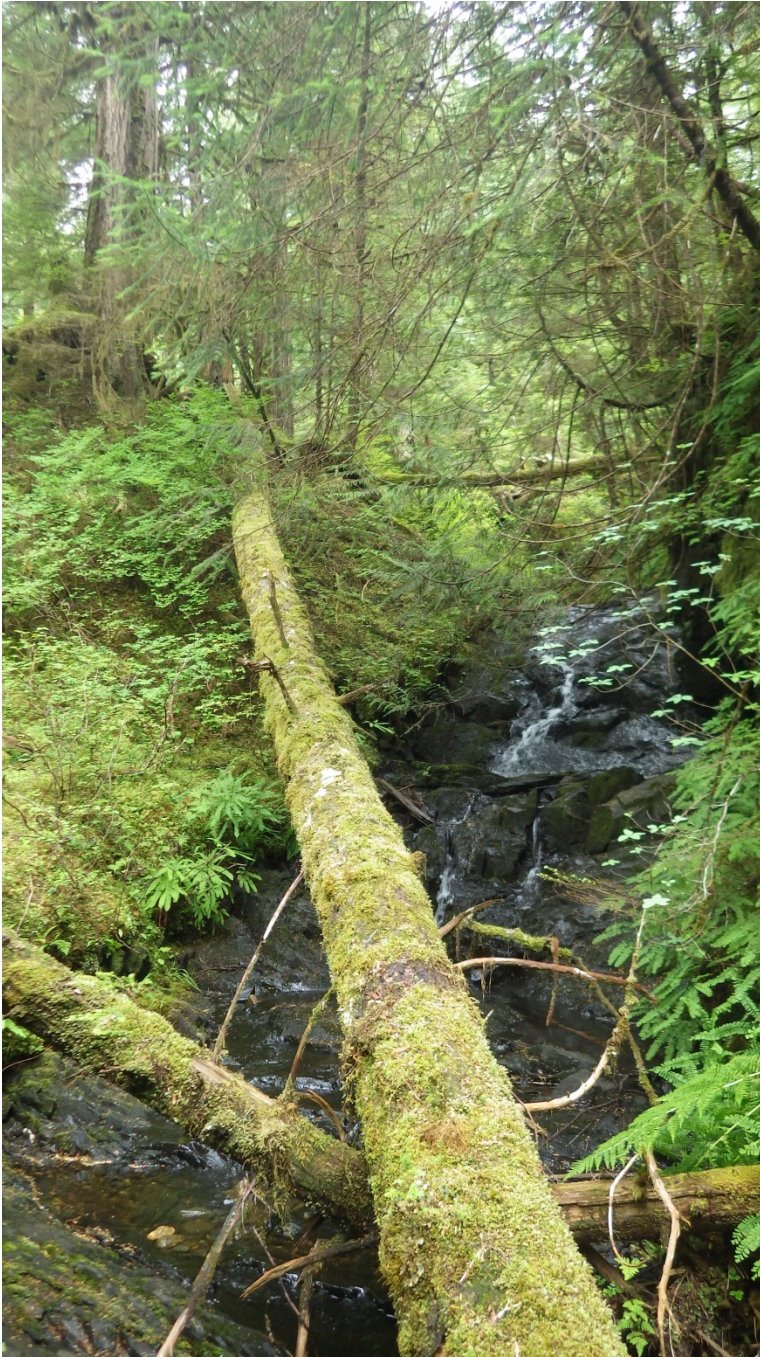
Waypoint	Latitude	Longitude	Notes	Sample Effort	Sample Results
559	56.1263	-133.1456	Start survey.	VI	CO
560	56.1270	-133.1469	Braided logjam section.	EF	No Fish
561	56.1286	-133.1488		EF	6 CO
562	56.1292	-133.1501	Trib on RR, proceeding up.		
563	56.1288	-133.1503	Large barrier falls on trib. Two separate falls, with shallow pool/step between in between (6 ft falls, a step, then a 4 ft falls). This is composed of bedrock. This is a fish barrier, end survey.		
564	56.1292	-133.1503	Back on main channel, proceeding up.		
565	56.1300	-133.1521	3.5 ft drop/falls on a rearing-only stream. This is a barrier. This is also the edge/border of a clear cut. End survey.

Figure 1.-Waterfall barrier at waypoint 563.

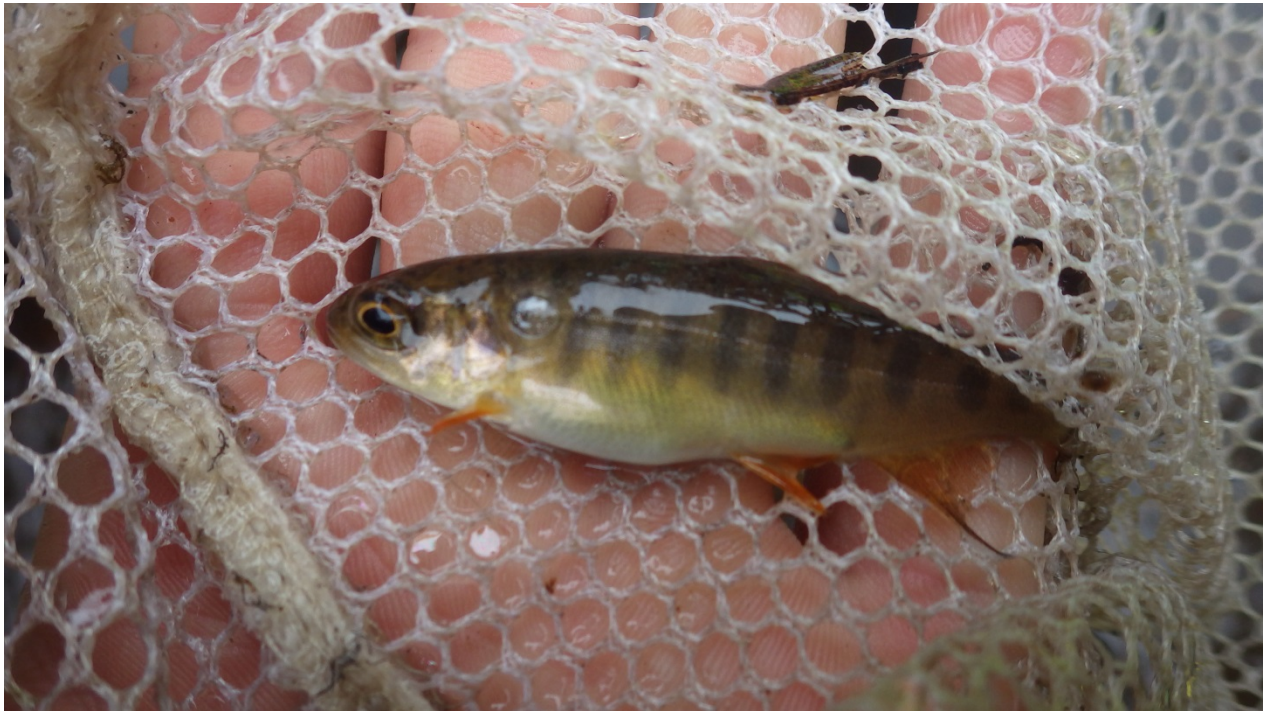
Figure 1.-Coho salmon captured at waypoint 638.
